Your survey report

West Mead, Manor Road, Wirral, Merseyside,
United Kingdom, CH63 1JA

Inspection date

01/07/2025

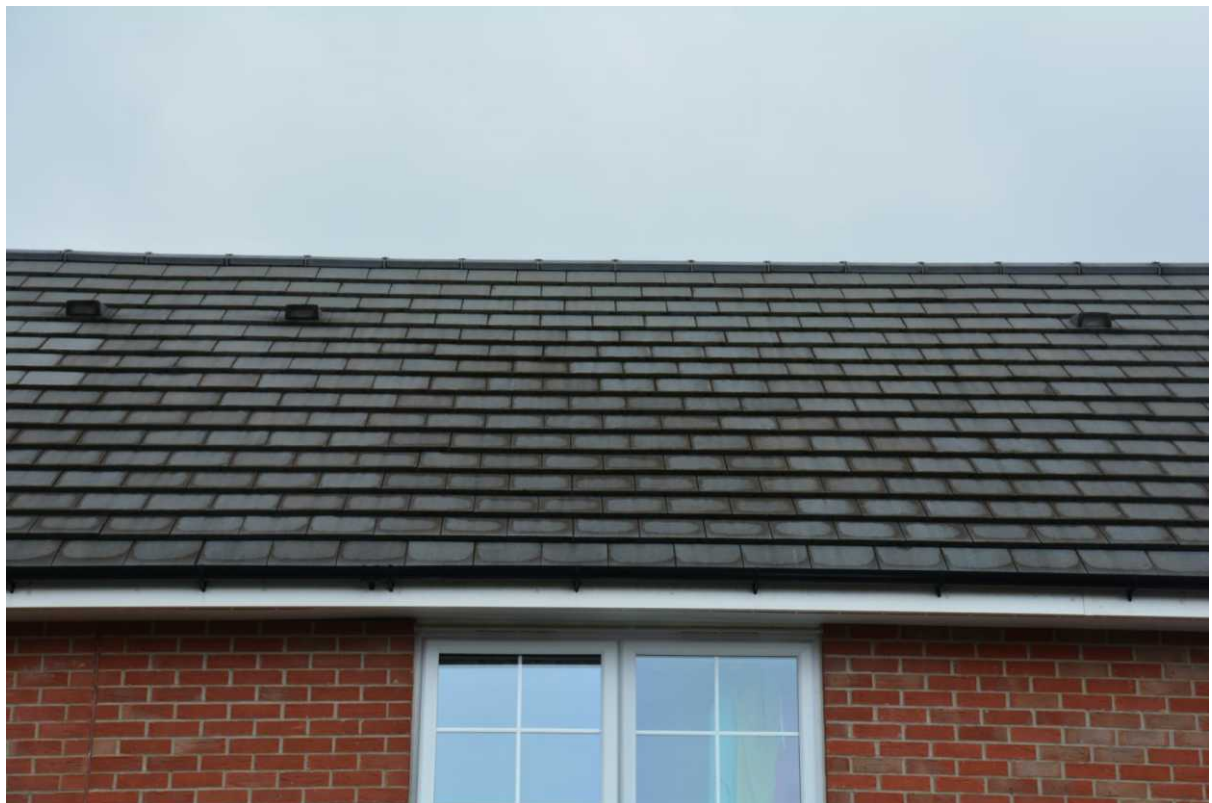
The ridge tiles are fixed in place using a dry ridge system which fixes the tiles in place with screws and clamps with waterproof unions beneath to divert water away from the join.

Dry ridge system.

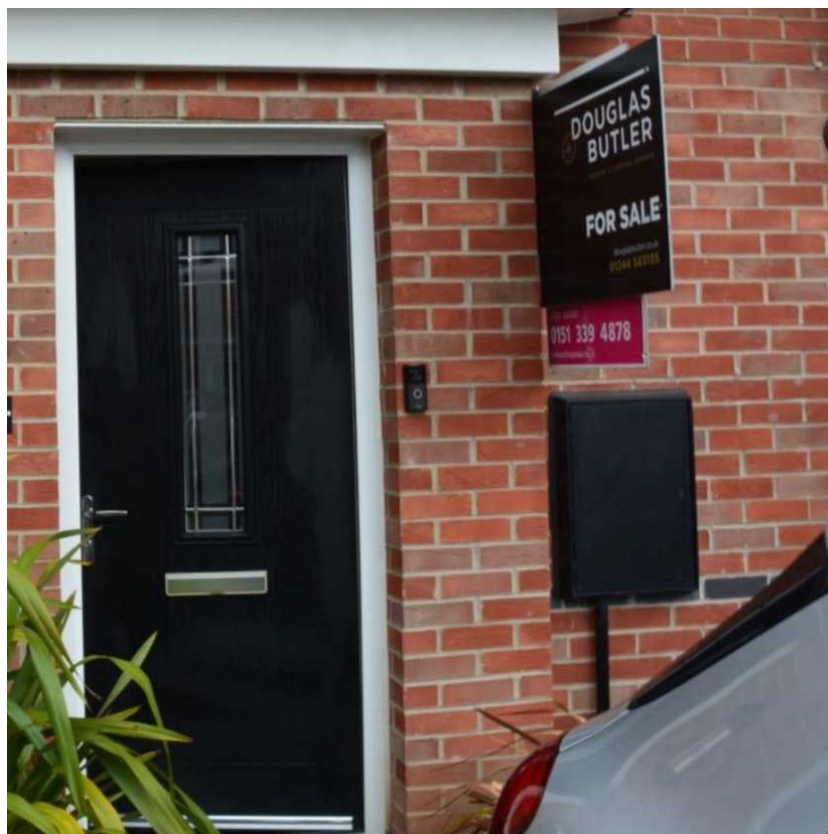
Doors open square to the eye with no signs of any significant movement or distortion noted. However, it was observed that the front door was difficult to operate and may need minor adjustments to get it working freely again. You should budget for any remedial work required.

Front door difficult to operate.

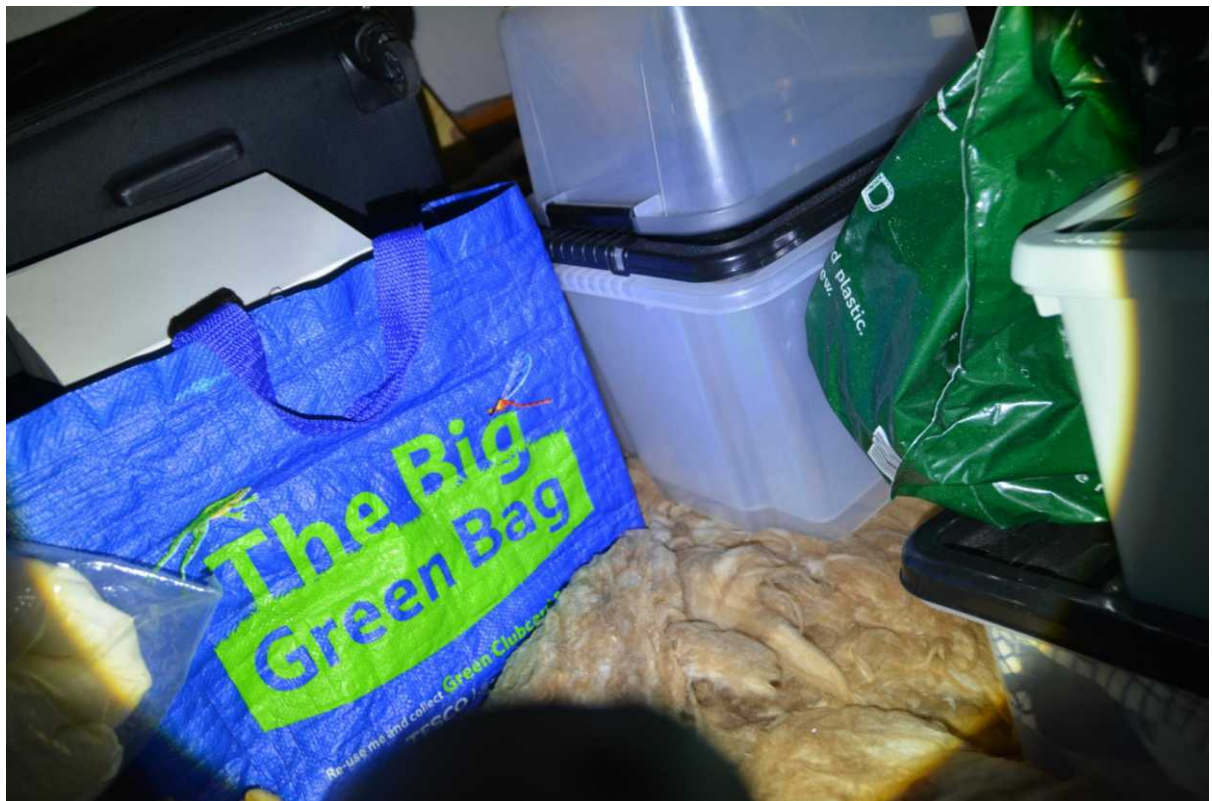
The roof space did contain items of storage, limiting the full extent of our inspection. Should you wish to use this area for storage it should be ensured that boarding is securely fixed and storage limited in order to reduce possible over-loading of the roof and ceiling structure.

Stored items.

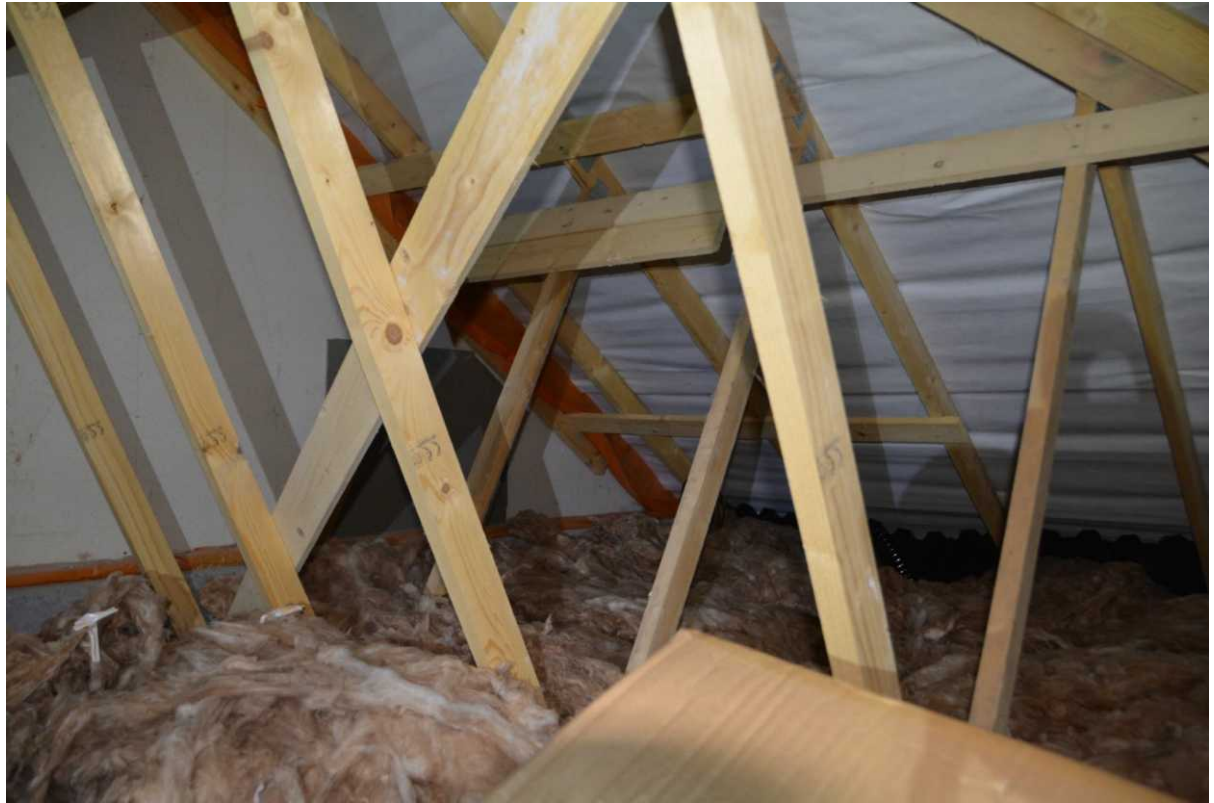
I am pleased to report we saw no signs of any timber decay to roof timbers that were visible at this time including any wet rot, dry rot or wood-boring insect infestation.

Trussed roof structure.

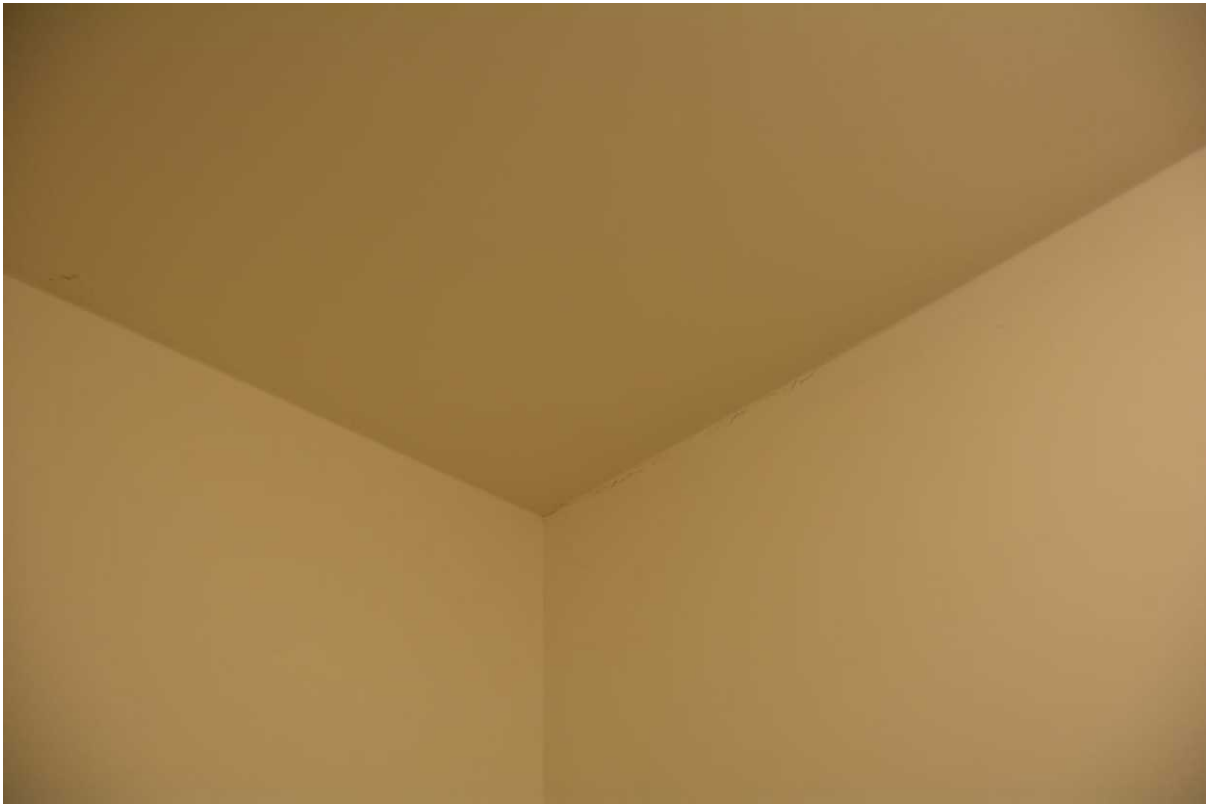
Cracks along the lines of plasterboard joints are not unusual. These cracks are not structurally significant and can be filled prior to redecoration.

Cracking along plasterboard joints.

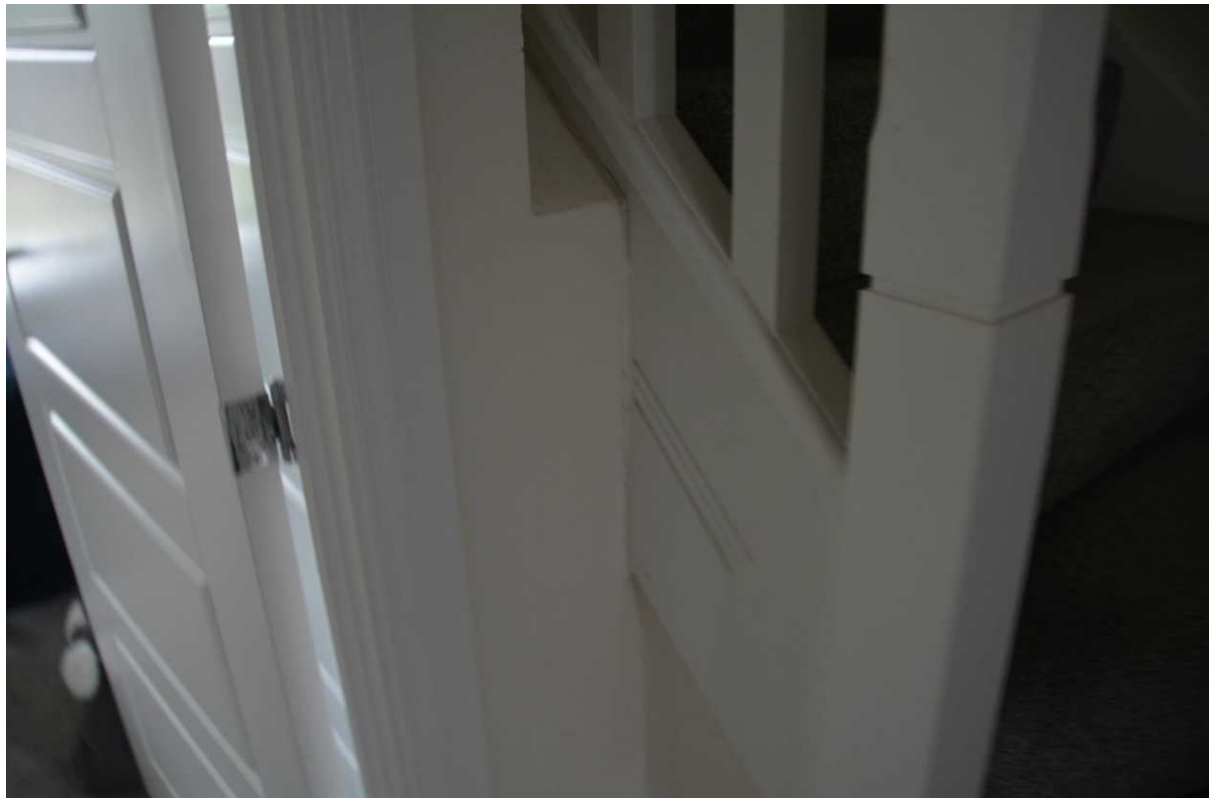
Some shrinkage cracks and irregularities are present in the plasterwork although these are not considered to be serious in a property of this age and an amount of making good is required prior to redecoration.

Shrinkage crack.

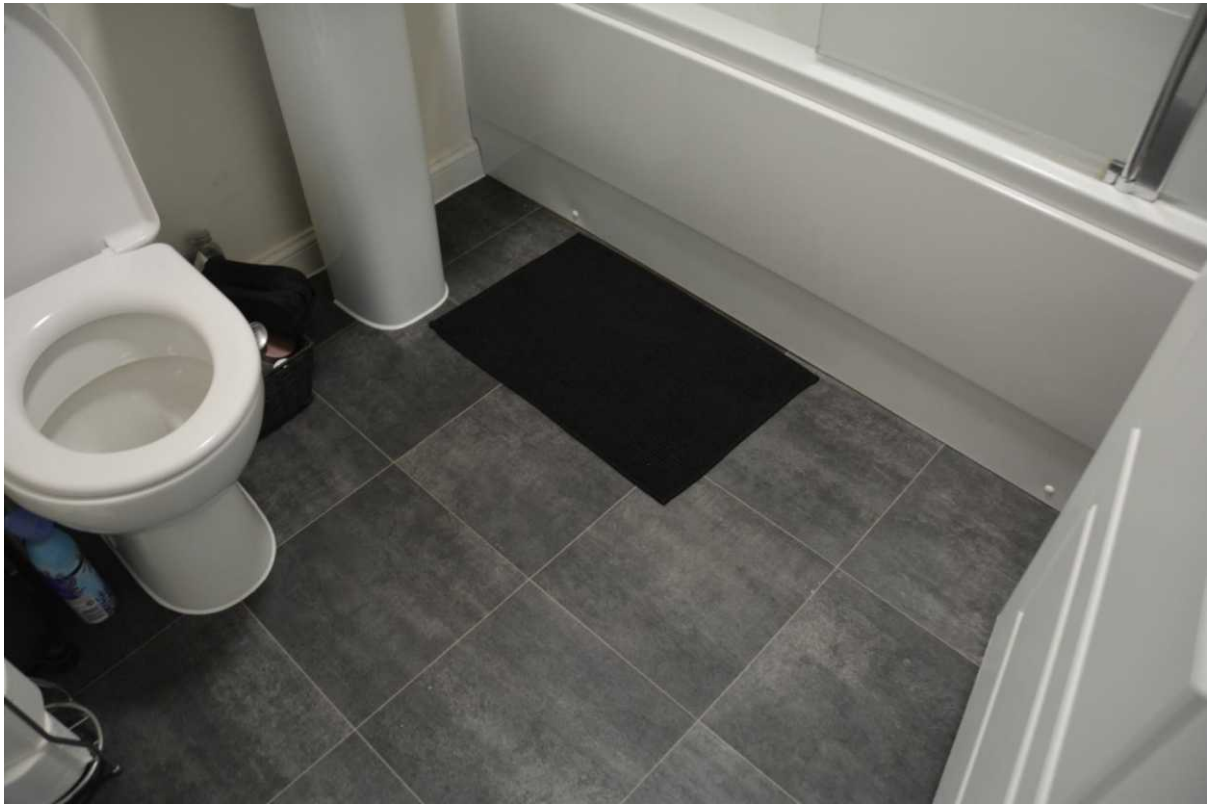
Vinyl coverings to the upstairs bathroom can trap moisture beneath which could cause damage to suspended timber floors over time. No repair is urgently required but we recommend you replace this floor covering with a more suitable floor covering in the long term.

Vinyl flooring.

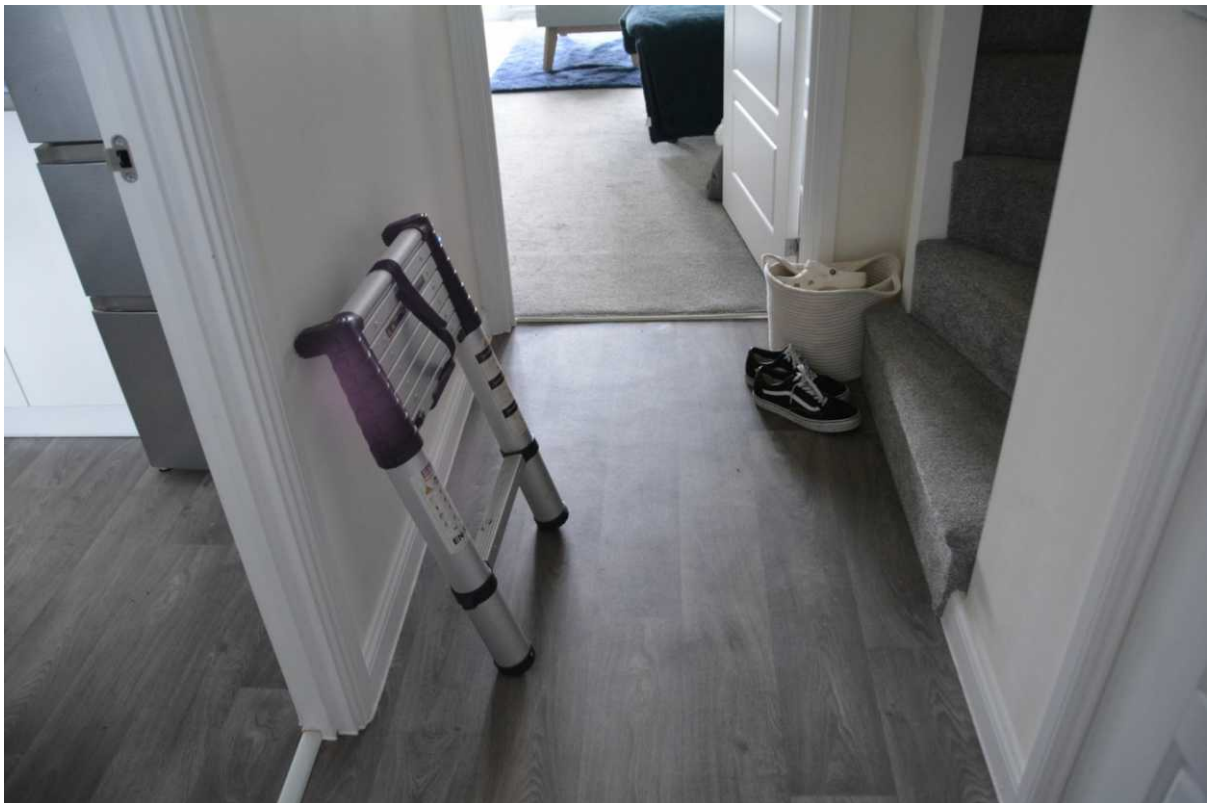
The flooring within the downstairs hall, kitchen and bathroom is believed to be a timber finish installed over a solid floor structure where we cannot confirm the condition of the underlying floor structure or whether dampness or other defects are concealed by the installation.

Floating timber finish.

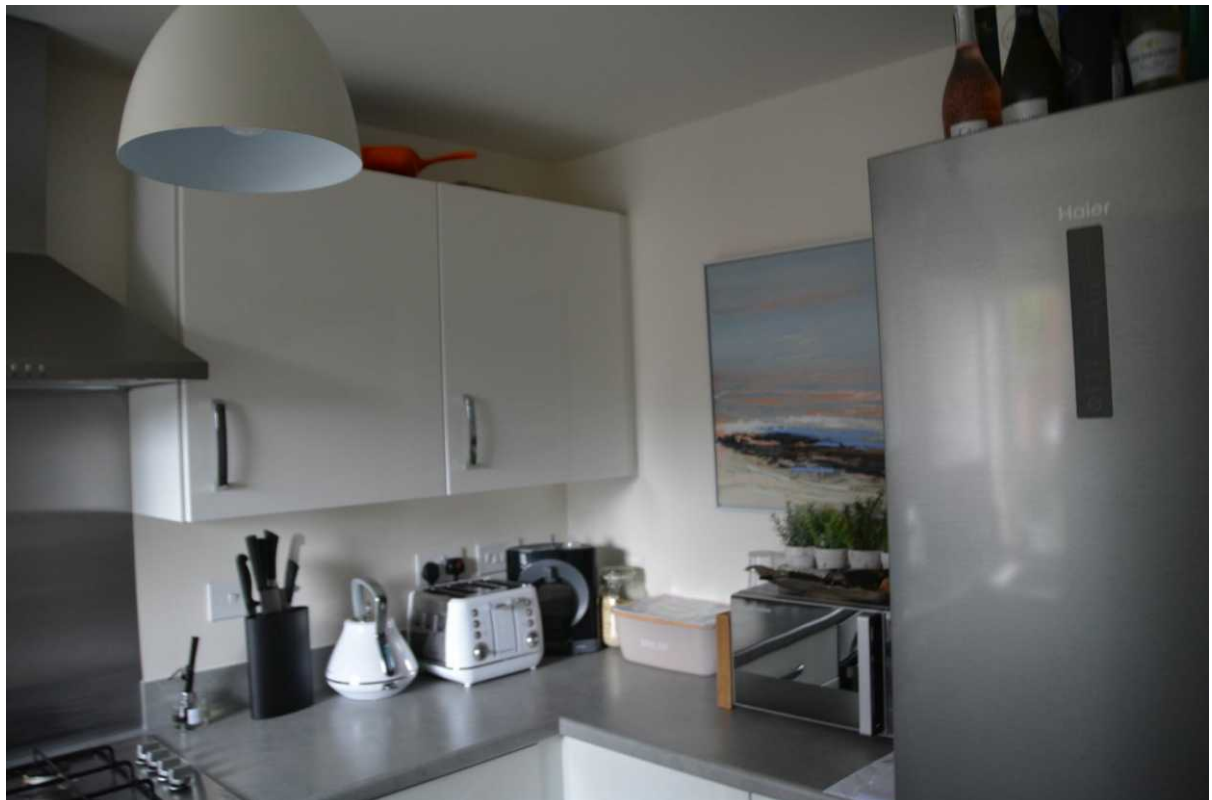
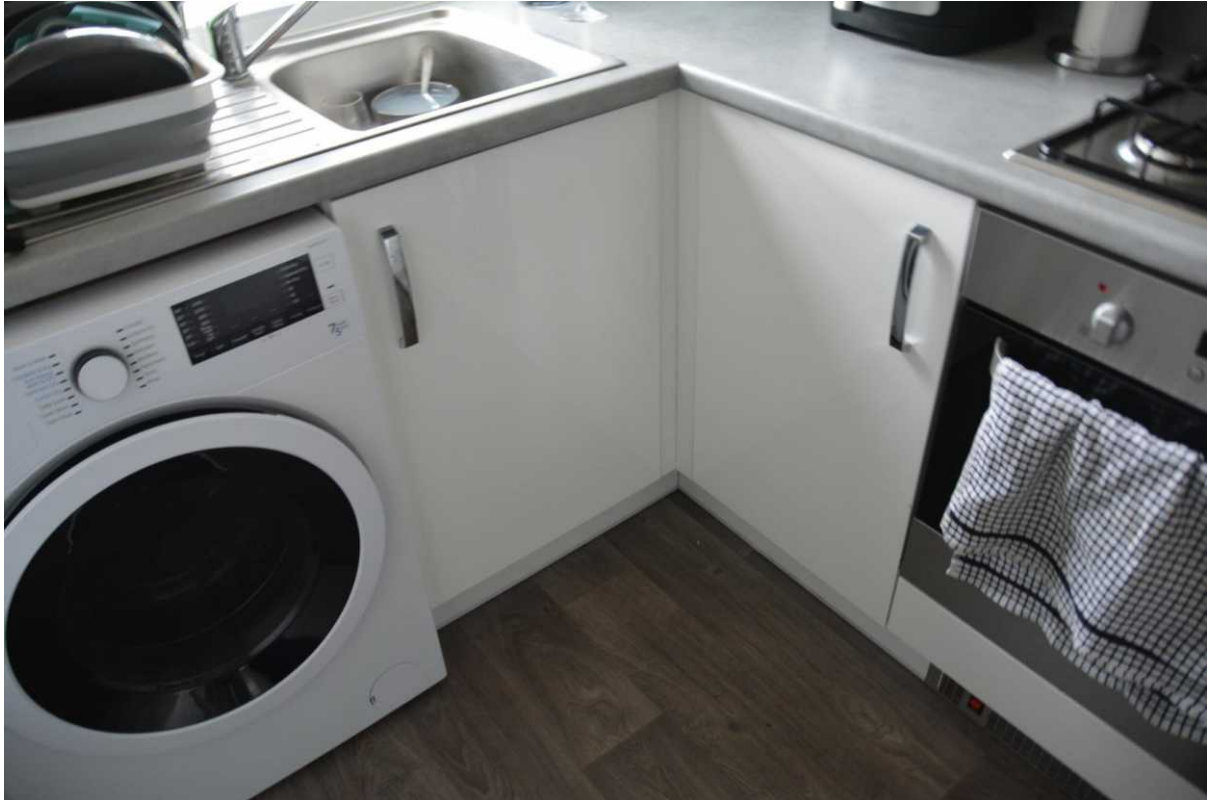
The fitted units provided are basic but relatively modern and appeared serviceable although individual units were not inspected in detail. Some wear and tear was apparent in association with day to day use.

Kitchen fittings.

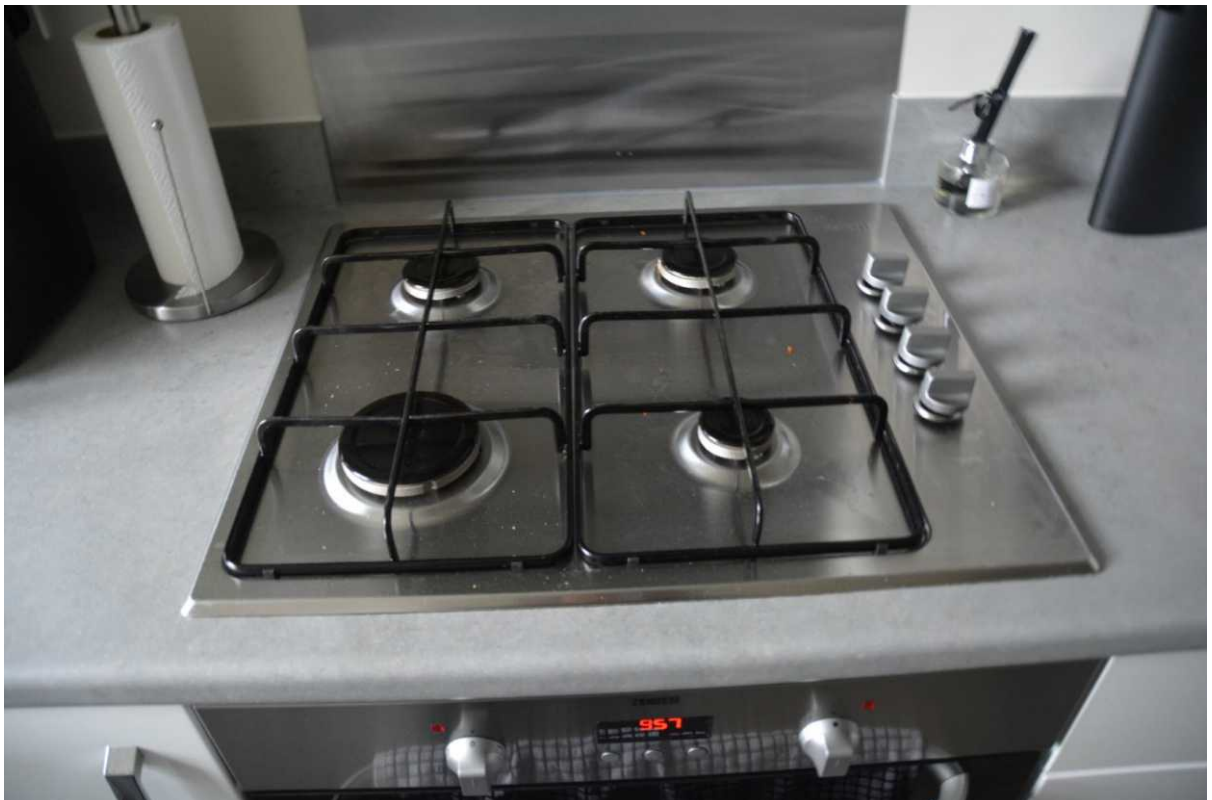
Gas hob.

There is a gas hob fitted and you should confirm with your legal adviser whether this has any Gas Safety Certification. See Section F2 of this report.

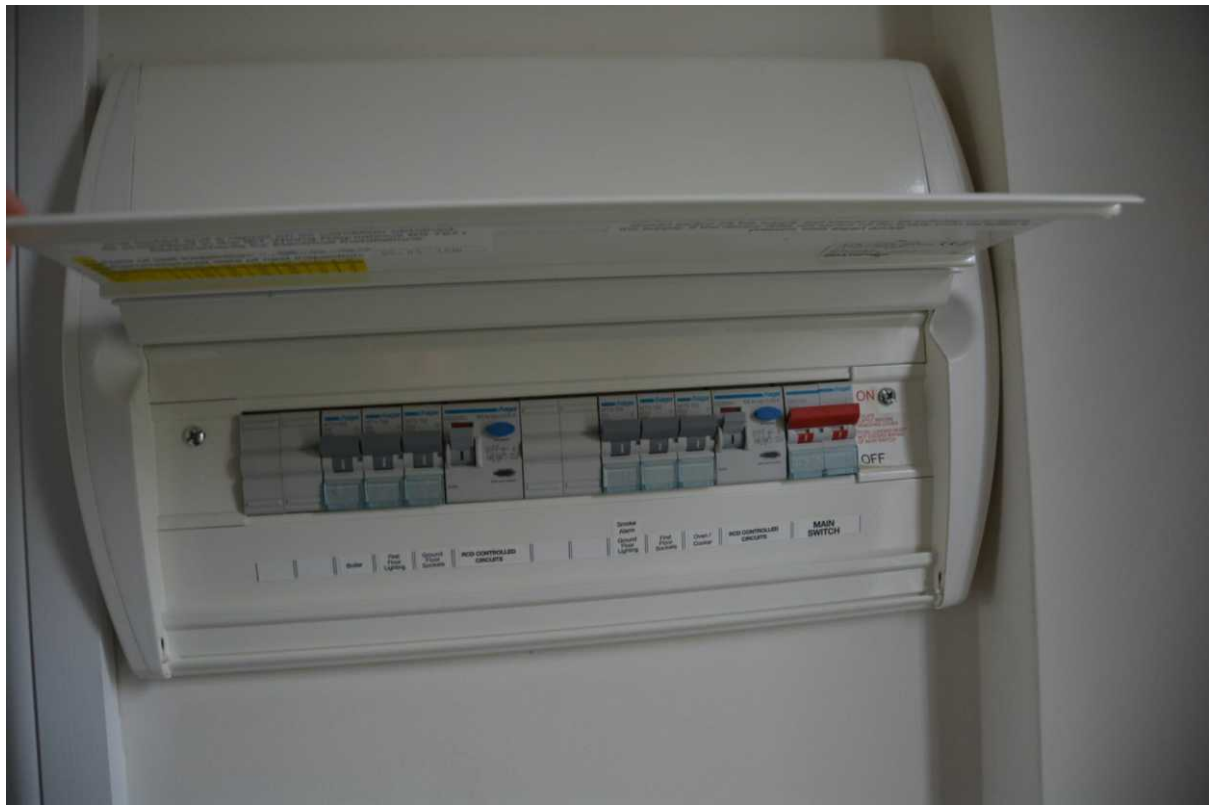
Consumer unit.

Although there were no areas of concern, a precautionary electrical inspection should be undertaken, to ensure that circuitry complies with current electrical regulations prior to a legal commitment to purchase. All recommendations should be implemented.

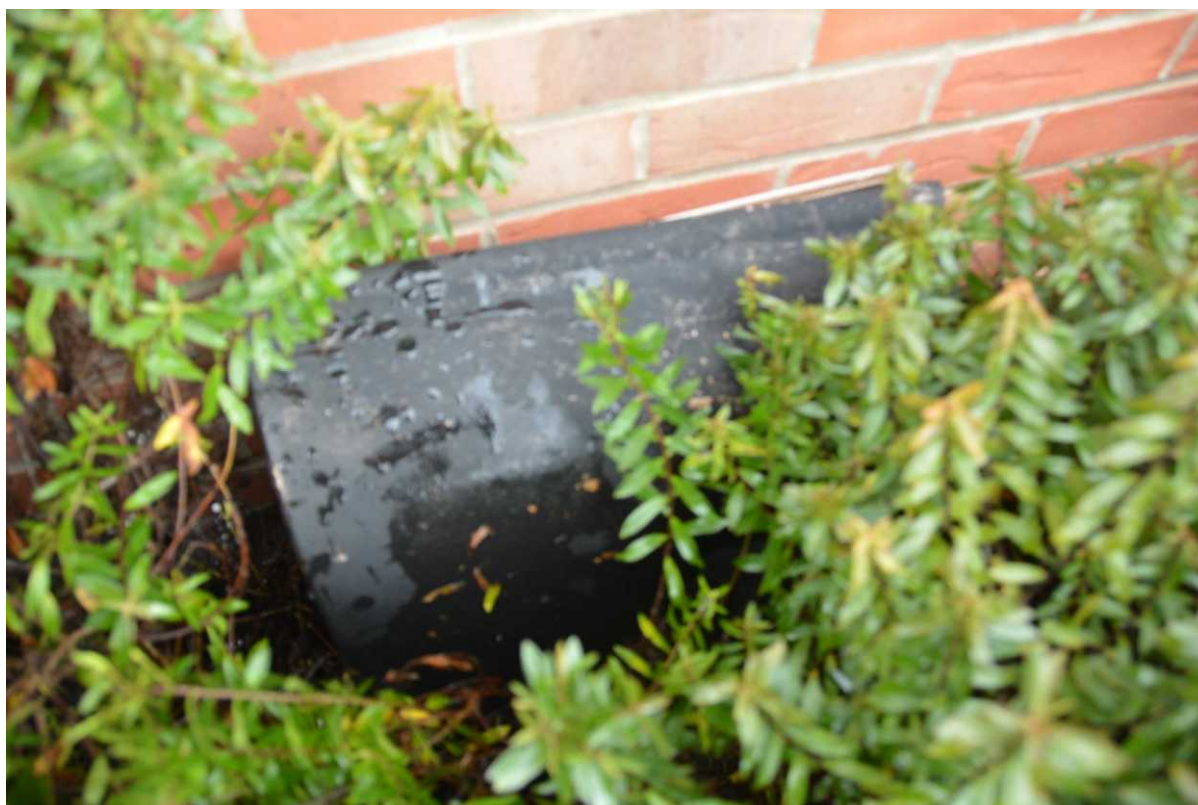
Gas meter.

For precautionary purposes it is recommended that the gas installation be inspected by a Gas Safe registered engineer prior to legal commitment to purchase in the absence of any paperwork in the last 12 months. Please note annual gas safety checks are a statutory requirement for landlords and recommended annually during occupation. All recommendations for improvement to ensure compliance with current Gas Regulation standards should be implemented.

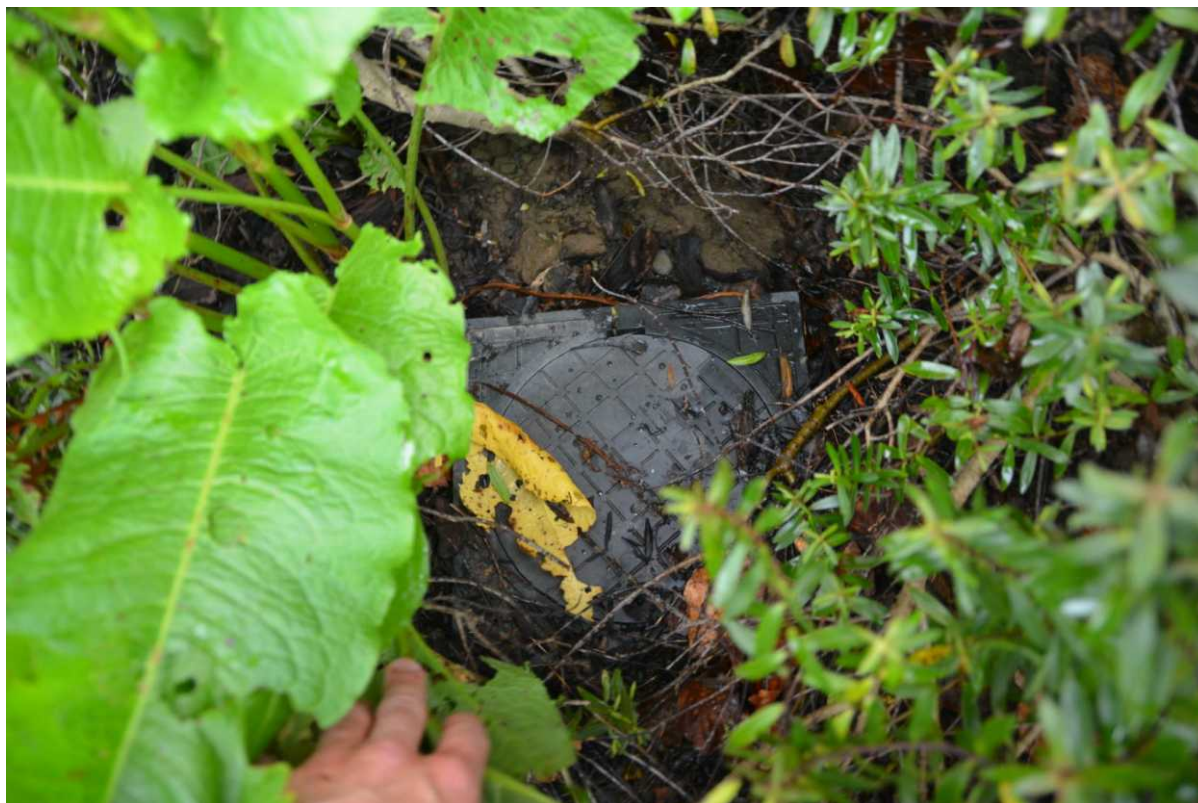
The external stop tap is located at the front of the property. You should confirm whether a water meter is provided.

External stop tap.

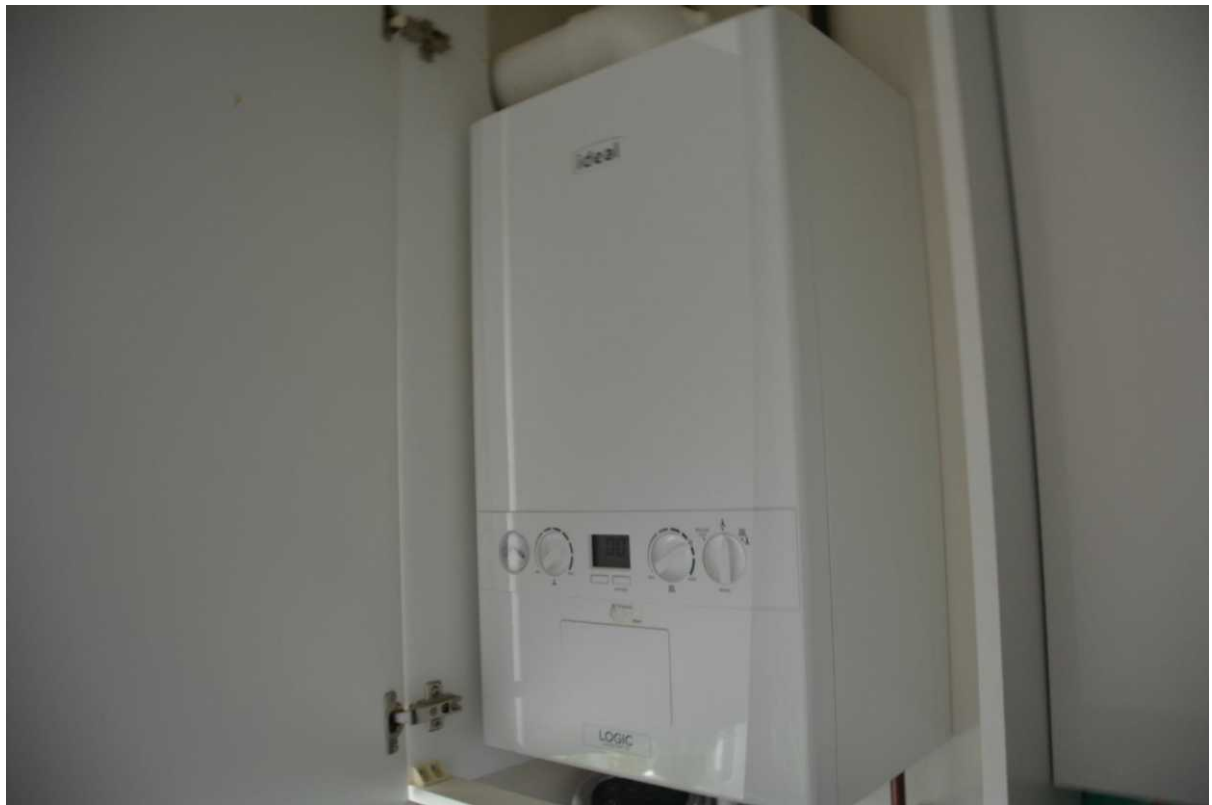
Gas boiler.

We are not suitably qualified to comment on the state and condition of the heating installation, a test on the installation is outside the scope of this report and we have not seen documentary evidence confirming recent service history. For precautionary purposes a heating engineer should examine the hot water and heating boiler and undertake appropriate servicing, with any recommendations to be implemented.
