LEVEL THREE

Your survey report

West Mead, Manor Road, Wirral, Merseyside,
United Kingdom, CH63 1JA

01/01/2025

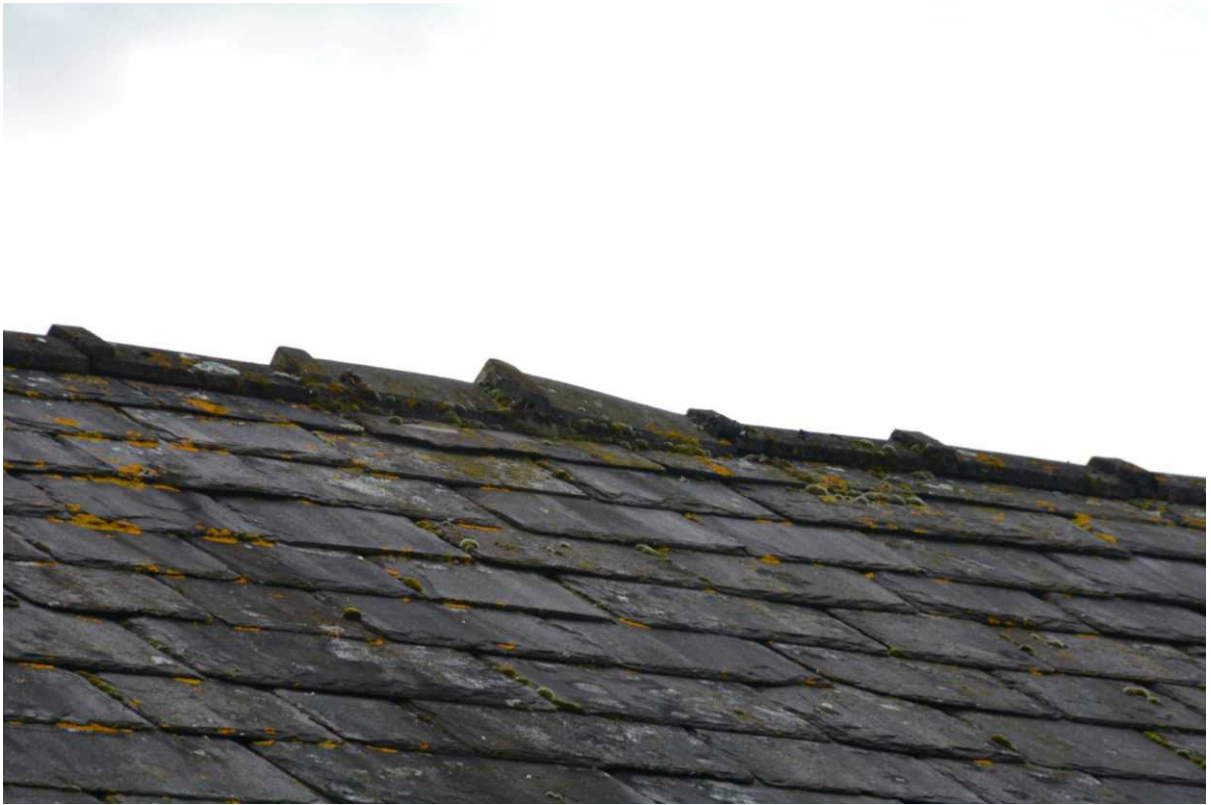
There is moss growth present on the roof slopes. Moss growth should be cleaned off as soon as possible. Moss growth impedes the run-off of rainwater and leads to gutter blockage and can cause water penetration which may lead to rot or other defects in surrounding timbers.

Moss present to ridge tiles.

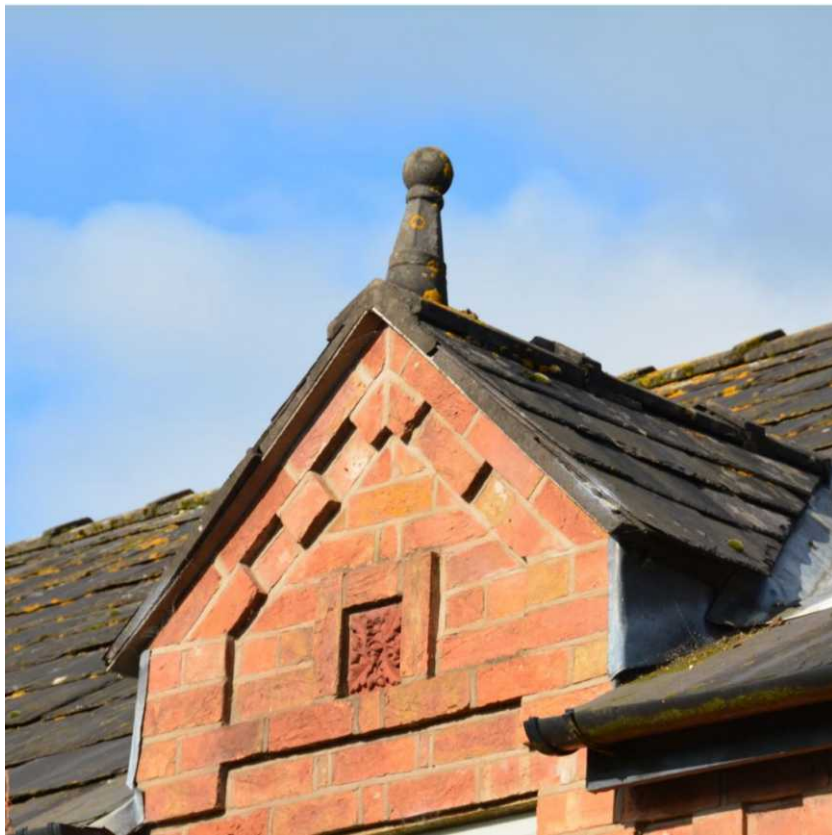
The mortar to the roof edge is cracked in areas. Whilst no remedial attention is required at present, the situation should be checked occasionally and the repairs addressed when necessary.

Cracked verge mortar.

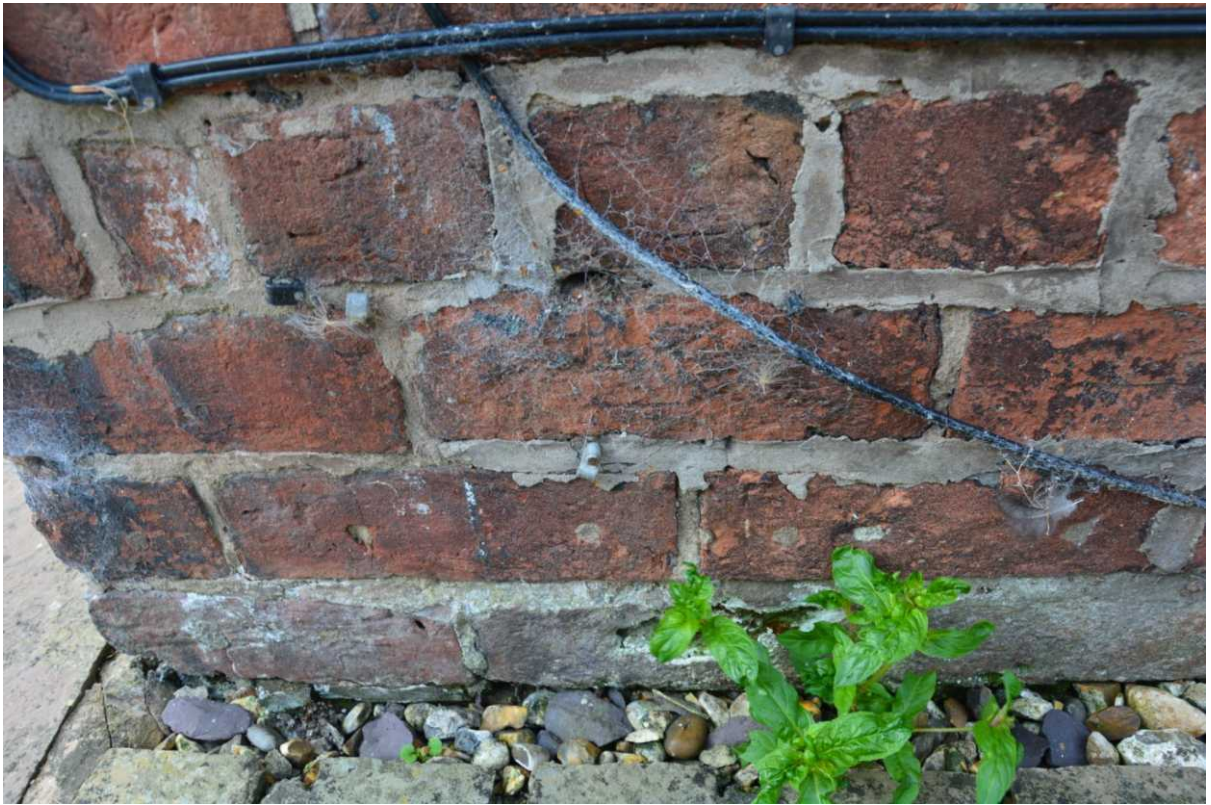
Holes have been drilled into the external walls at low level which appears to indicate a chemical damp-proof course has been installed to such areas. The incorporation of a chemical damp-proof course in a property of this age is not uncommon. Recommendations made in Section E3 of this report must be concluded prior to making any legal commitment to purchase the property.

Remedial DPC.

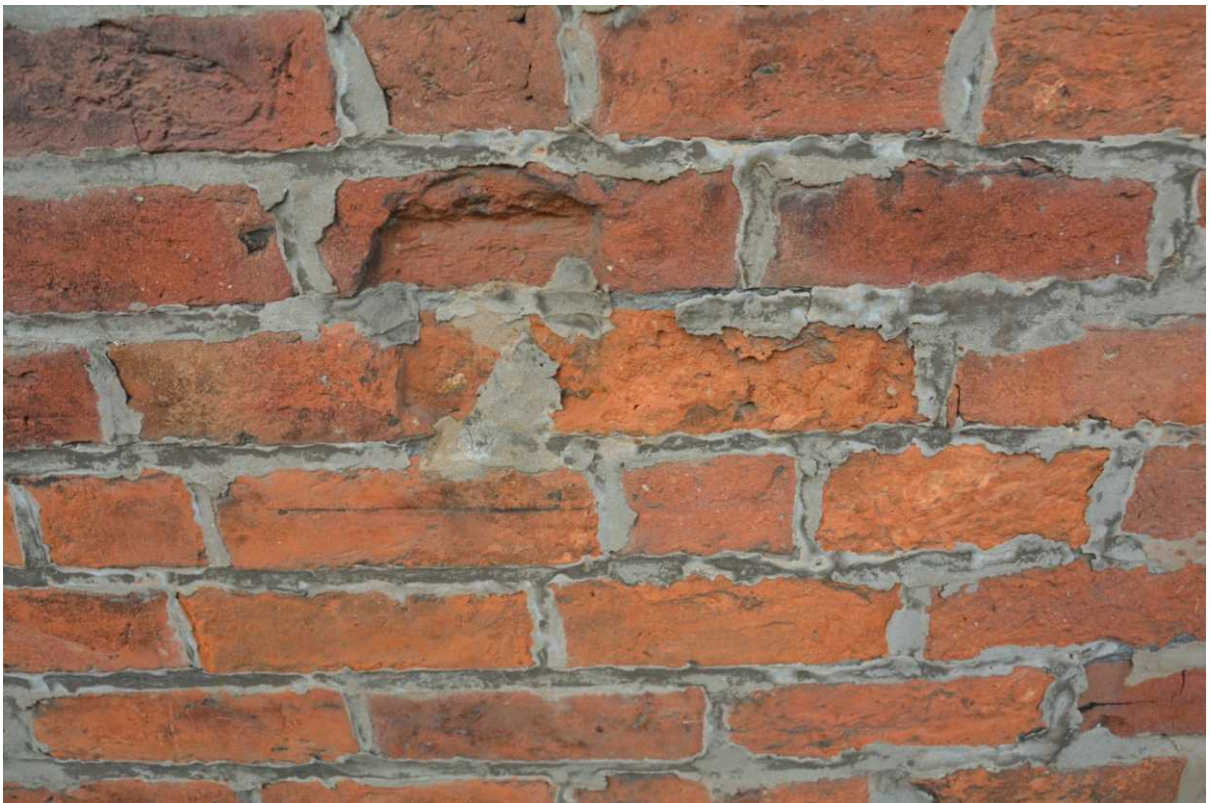
A number of spalled bricks are present to the external elevations. Spalling occurs when brickwork becomes wet due to rain. If freezing conditions occur before the bricks dry out, the entrapped moisture expands and forces off the hard face of the brick, so exposing the softer inner core. The spalled bricks should eventually be cut out and replaced with new bricks. You should budget for any remedial work that may be required.

Spalled brickwork.

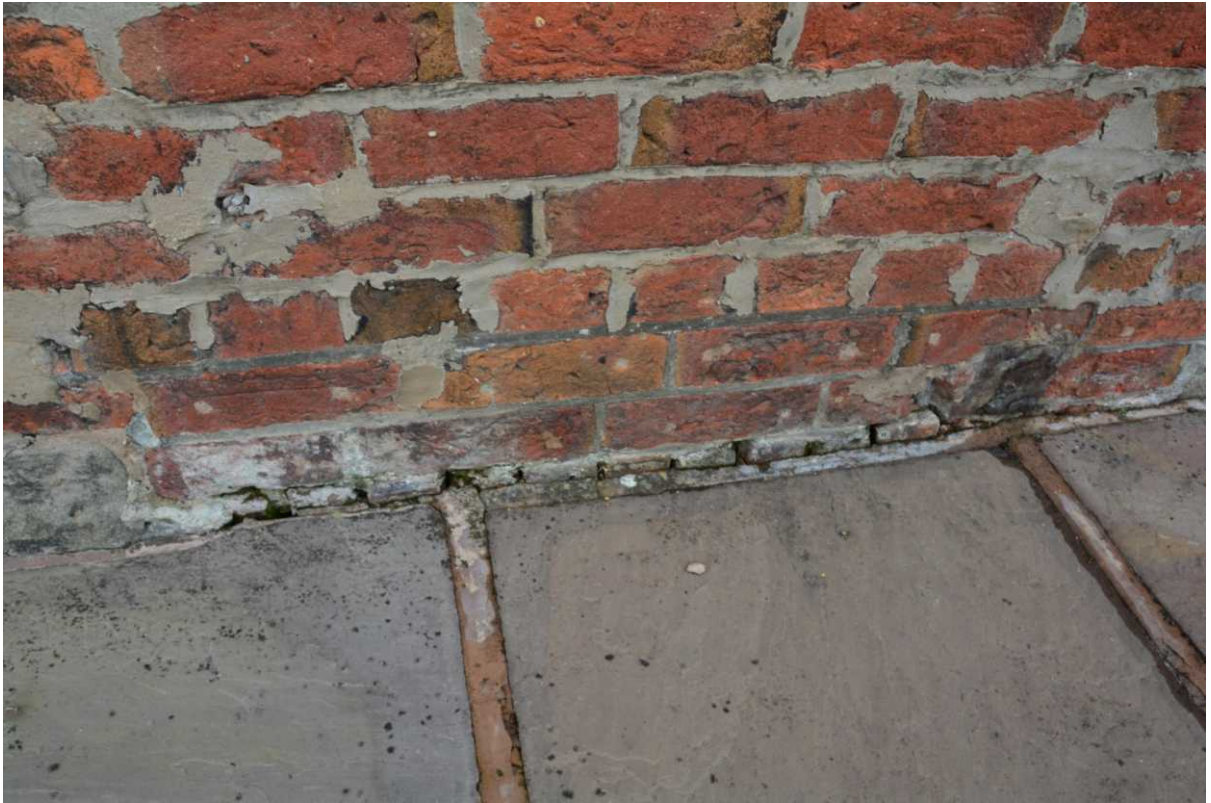
Repointing required to lower courses.

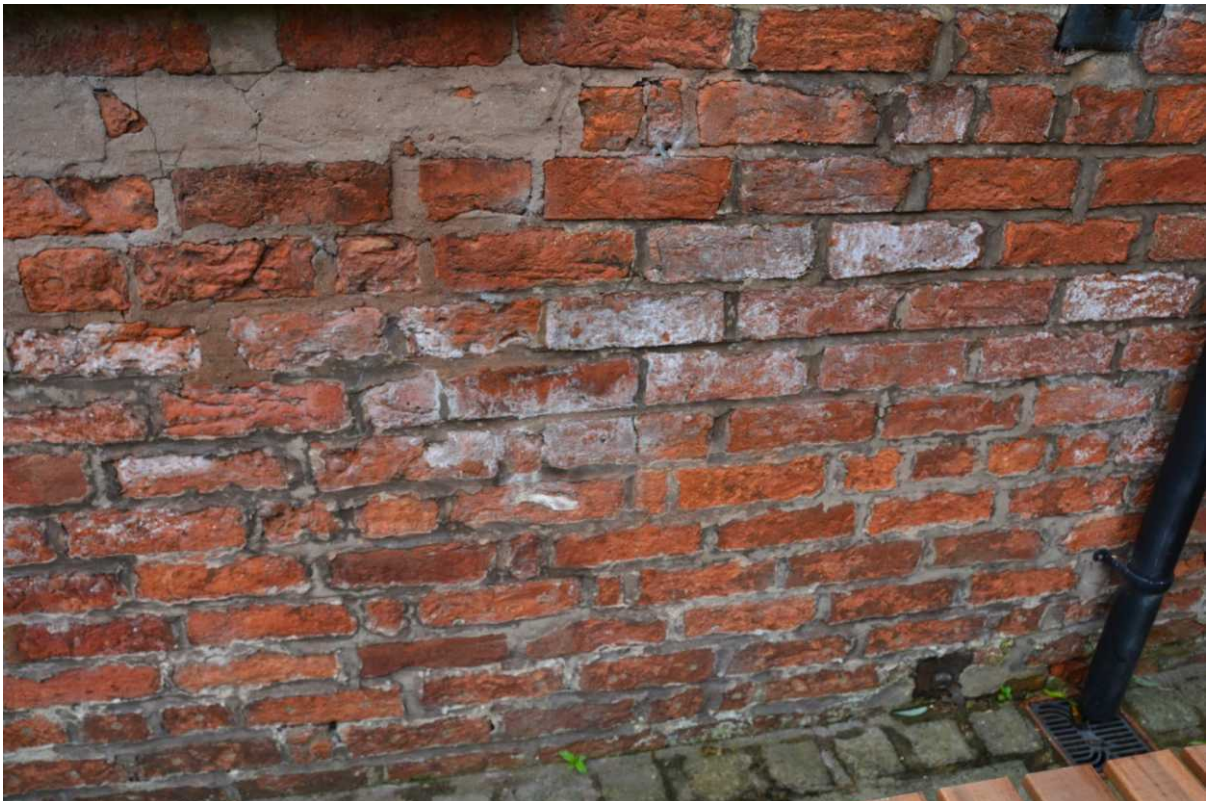
Efflorescence.

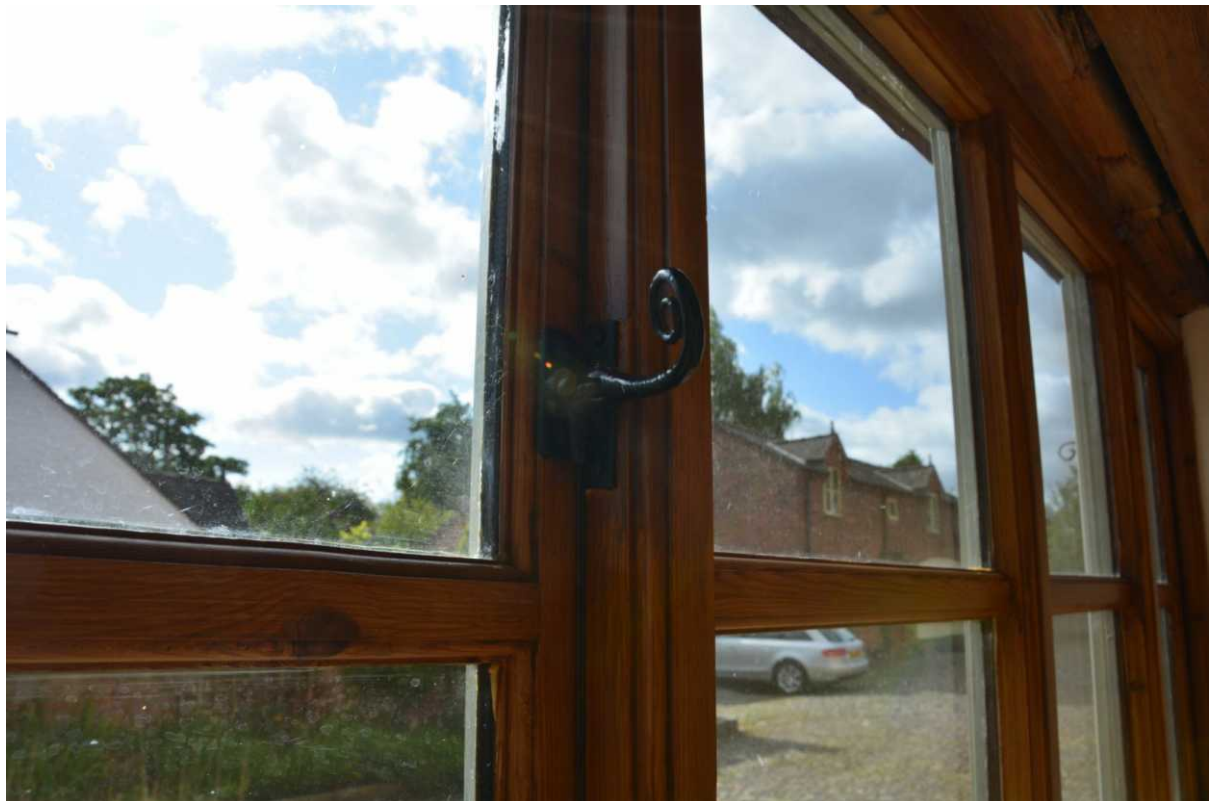
Alignment needed for handle.

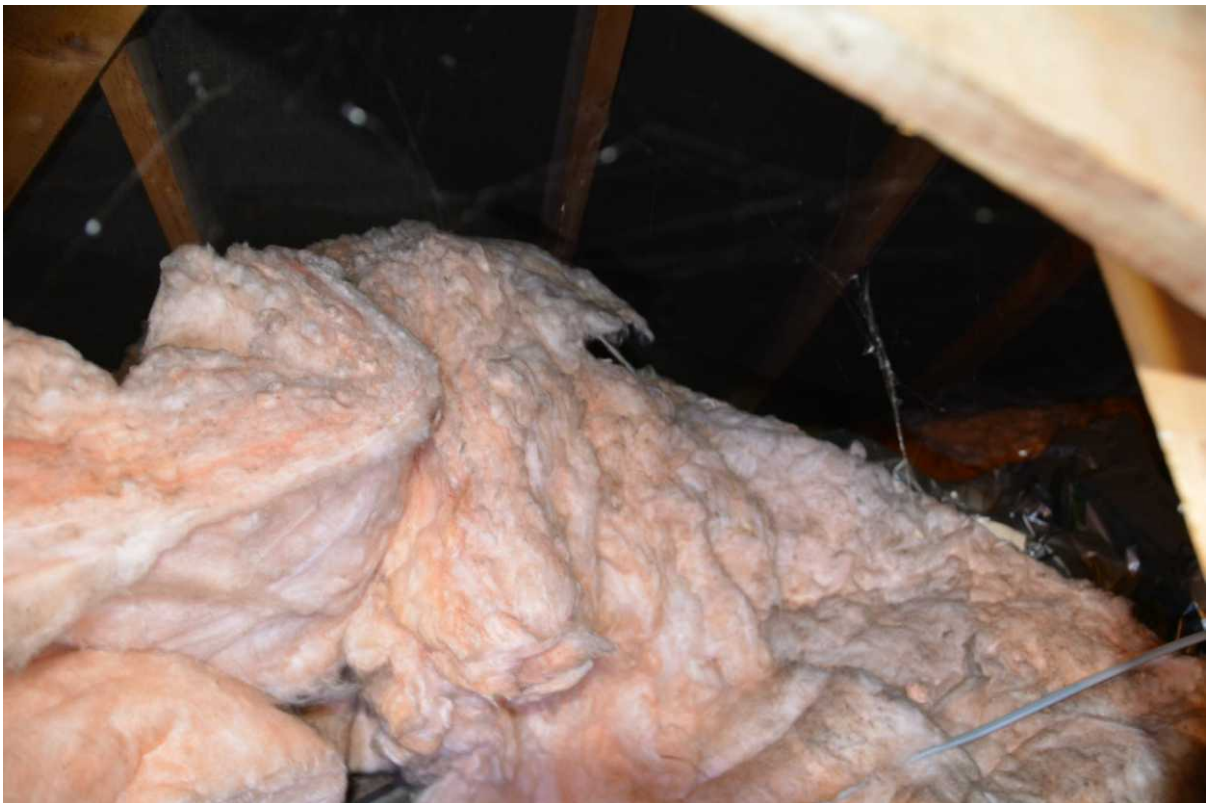
Wiring beneath insulation.

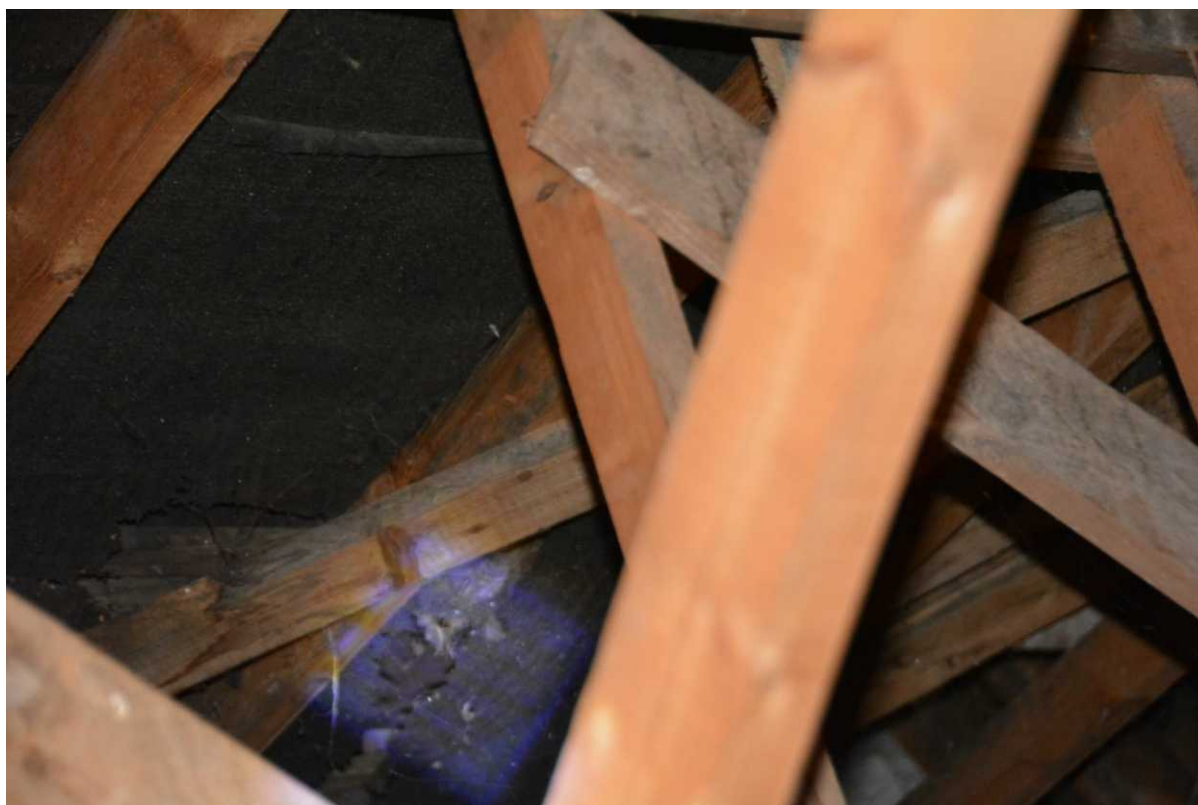
Torn felt.

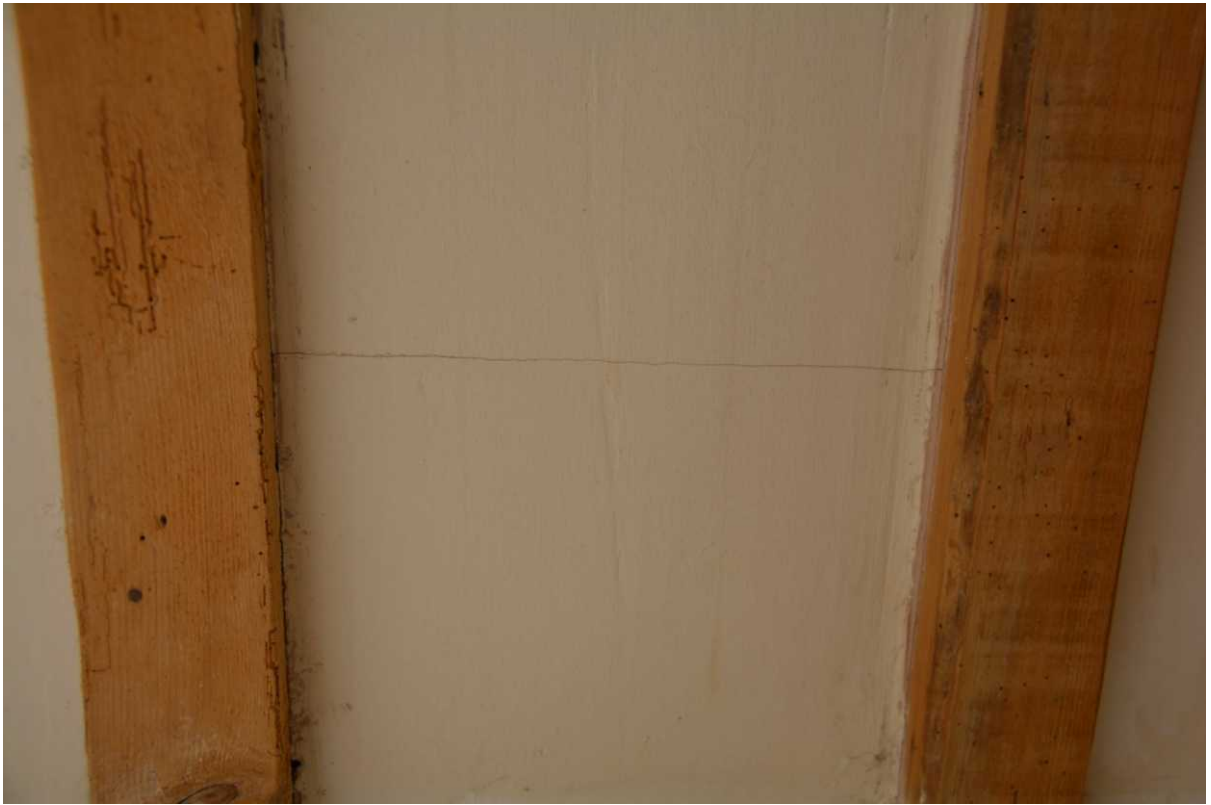
Shrinkage crack.

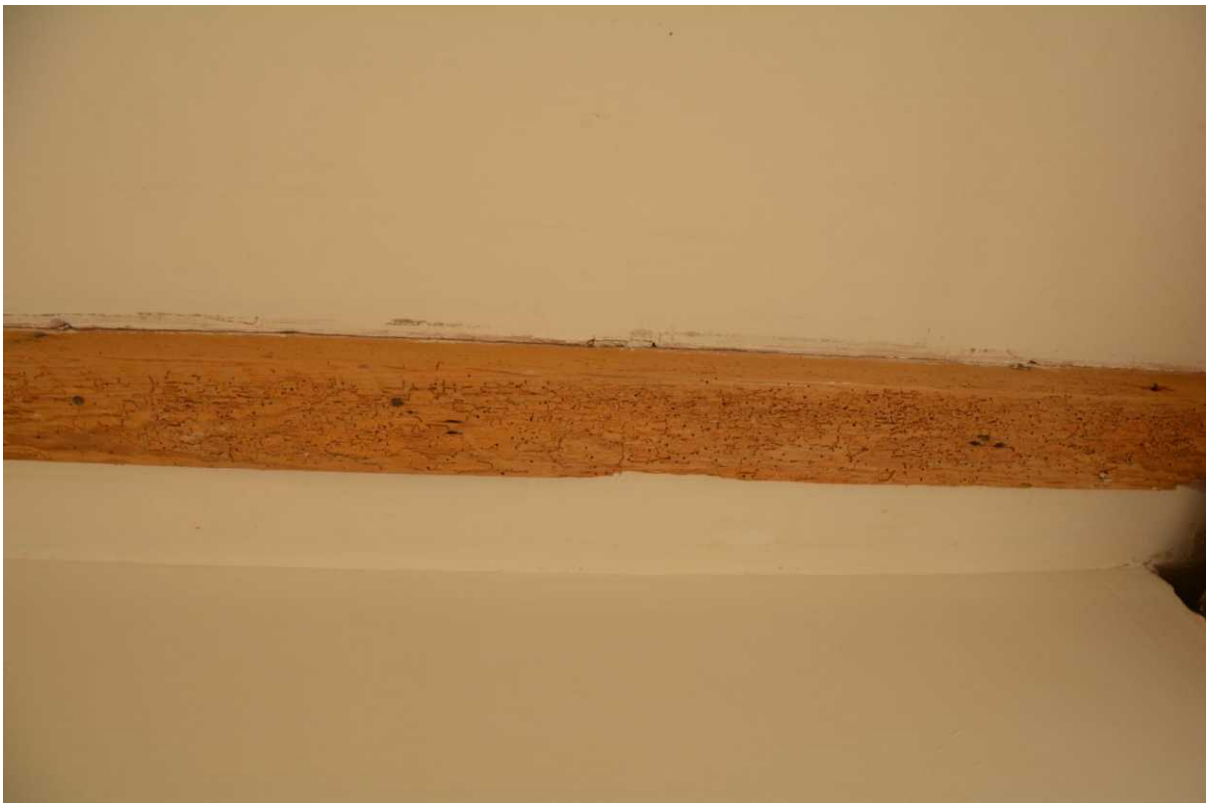
There is evidence of wood-boring insect infestation to ceiling joinery and whilst there were no signs of recent activity, you should confirm whether previous treatments have been made and if so, whether guarantees can be transferred under the sale.

Historic wood boring beetle activity.

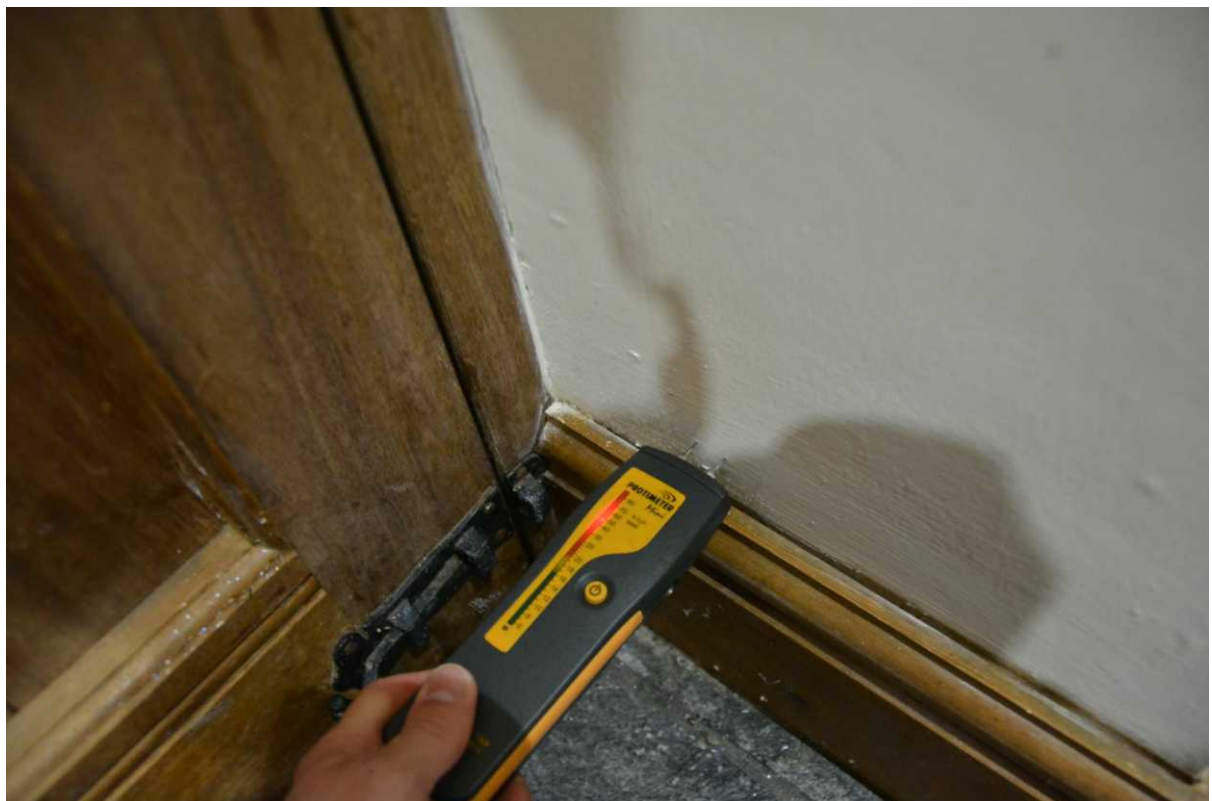
High moisture reading.

This does not constitute a complete inspection or a "damp" survey. Where readings taken are higher than normal, it is recommended you engage the services of a specialist contractor prior to exchange of contracts.

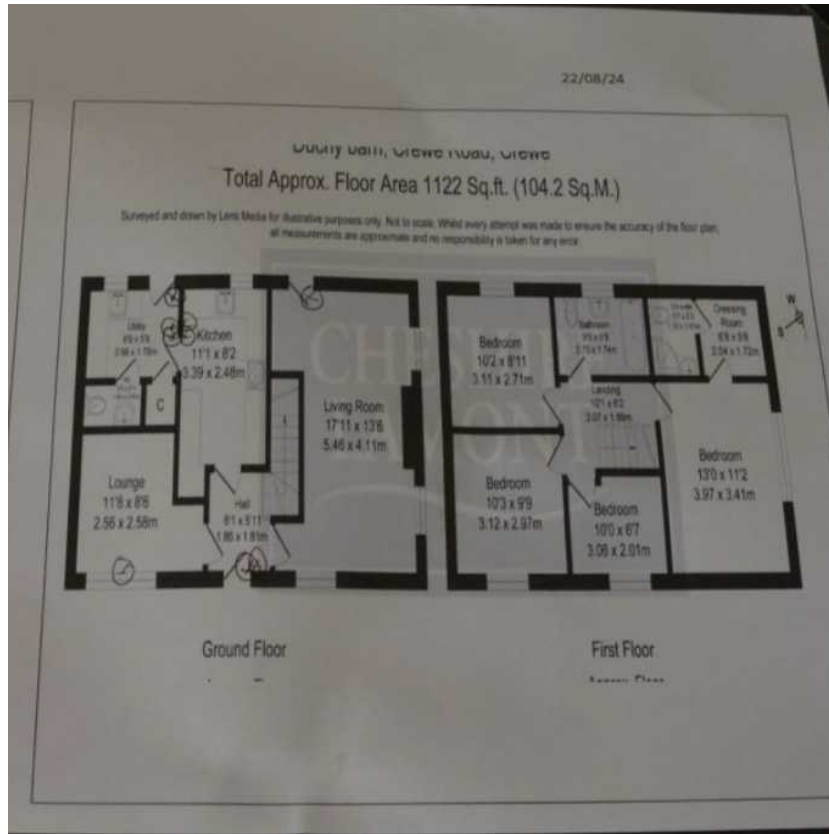
Areas of high moisture readings marked X.

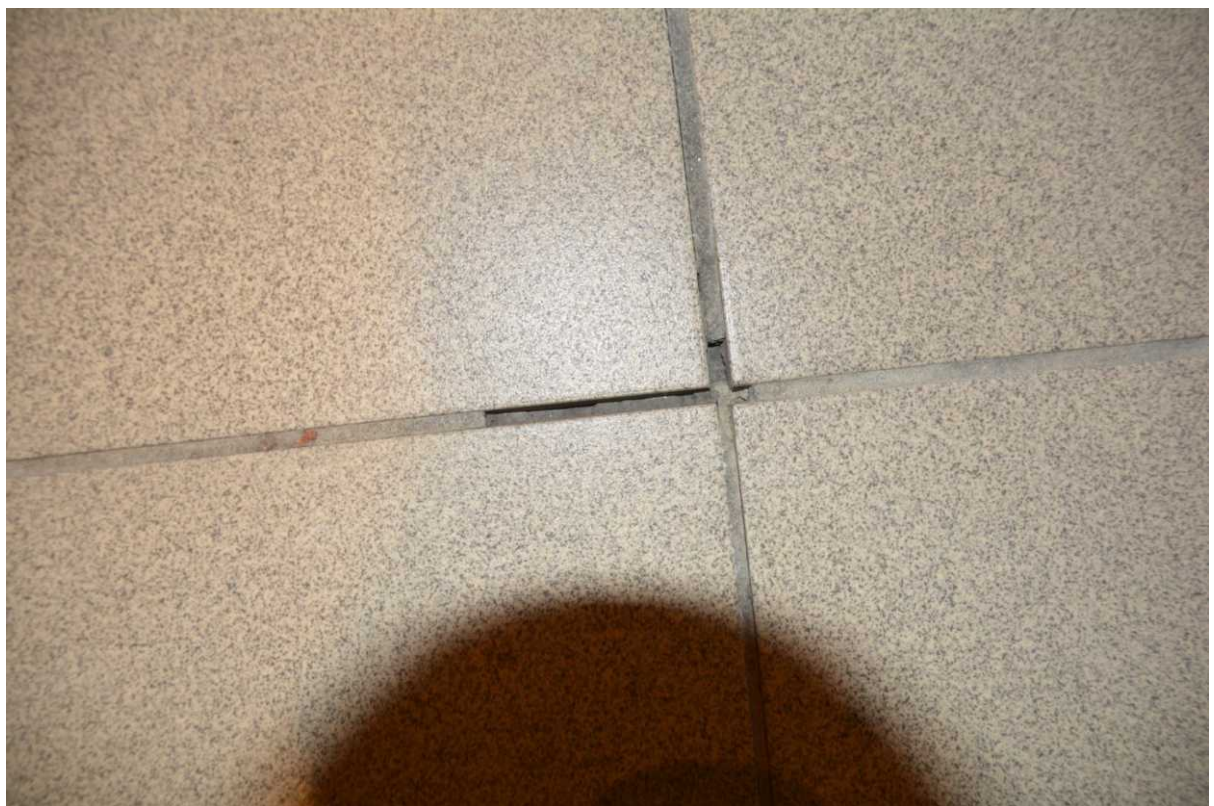
Grouting required.

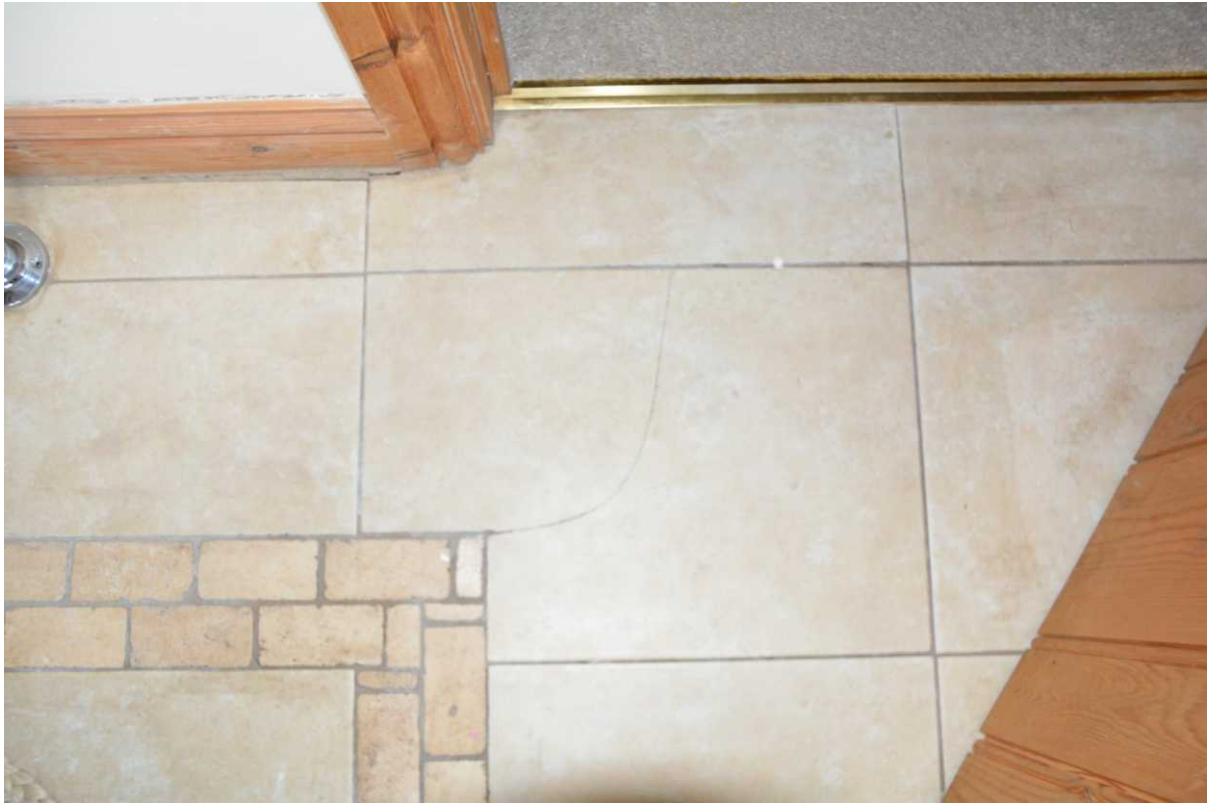
Cracked tile.

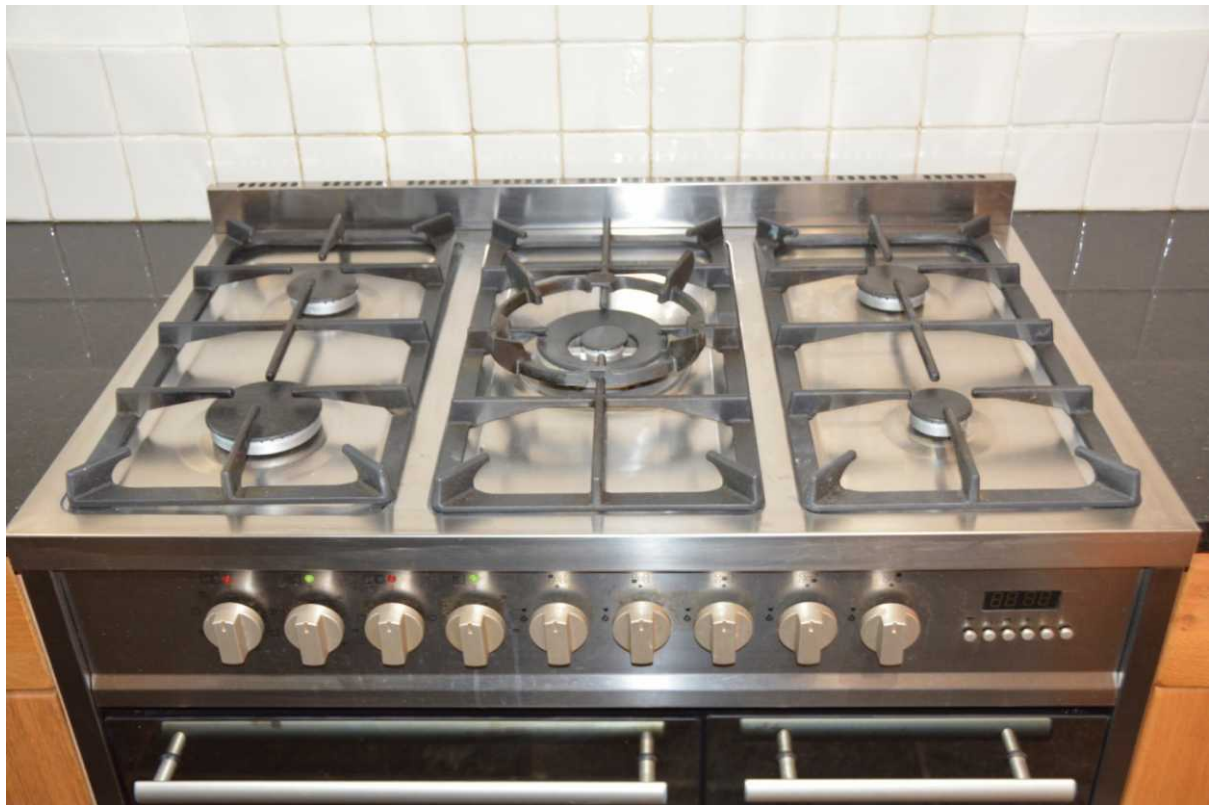
There is a gas range fitted and you should confirm with your legal adviser whether this has any Gas Safety Certification. See Section F2 of this report.

Gas range fitted.

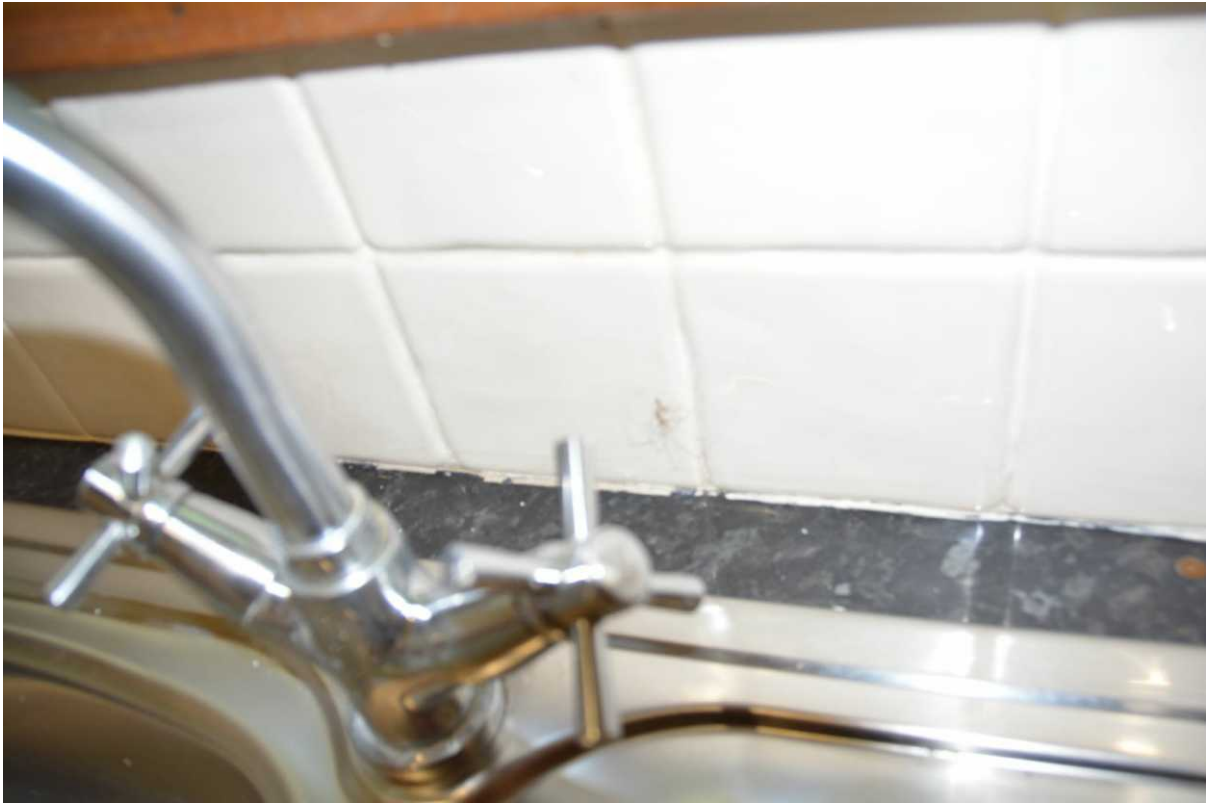
Sealant required.

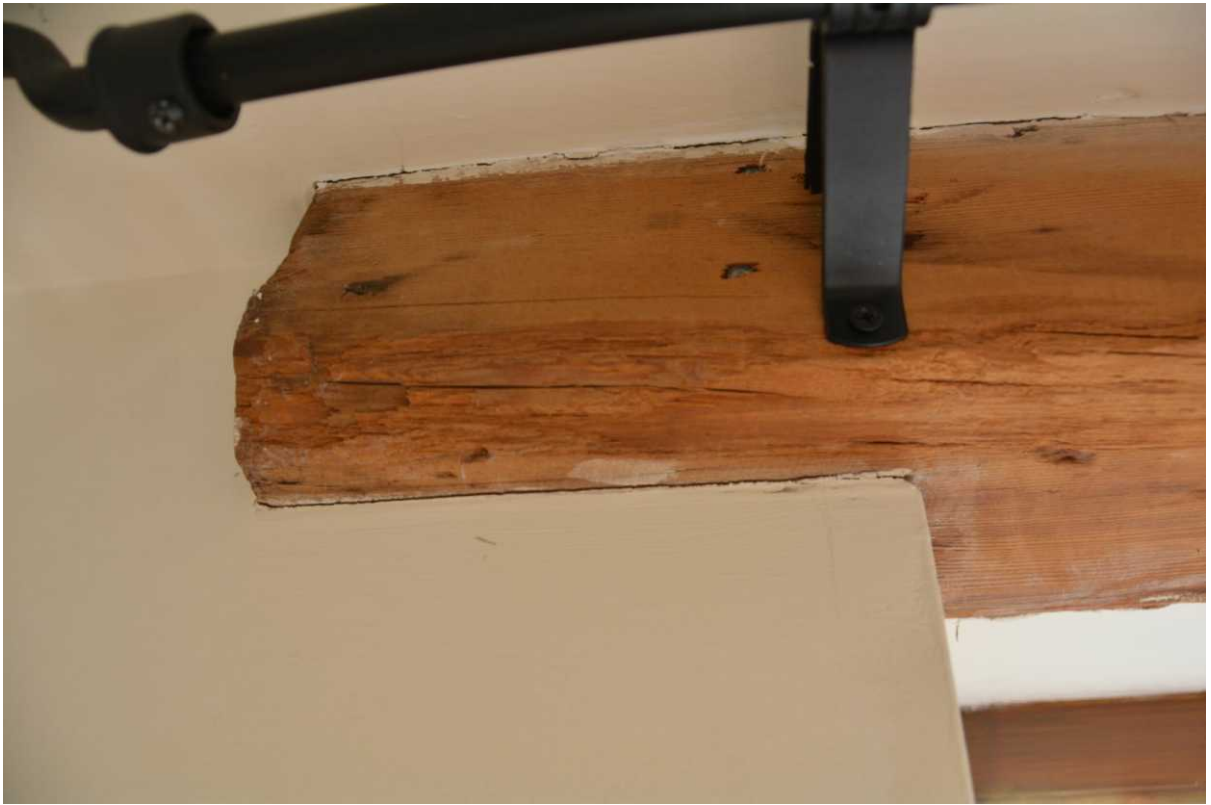
Softness noted to timber.

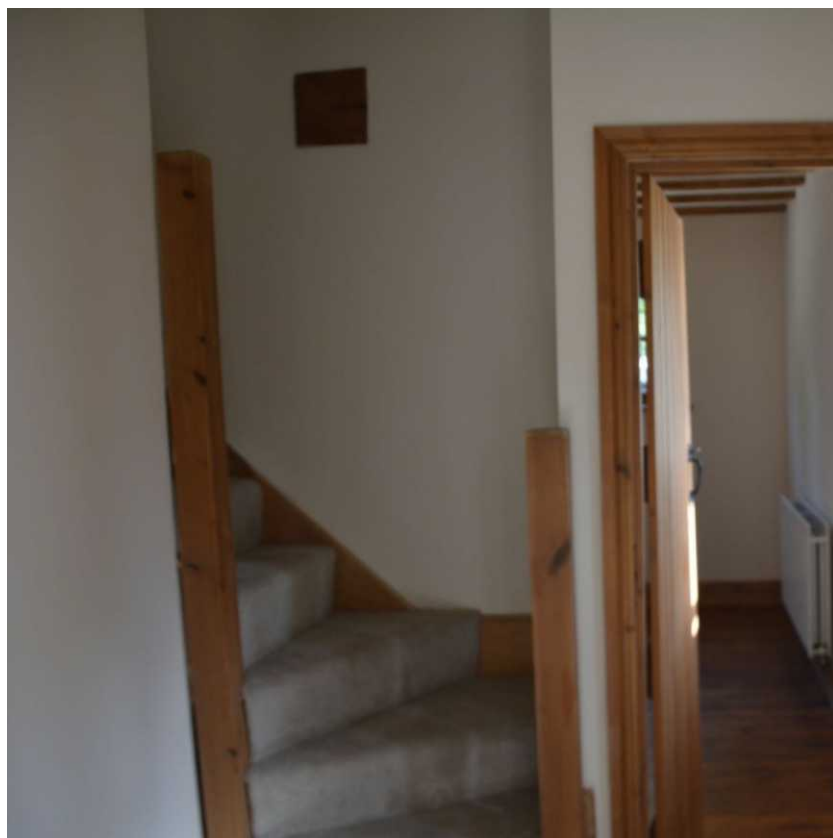
There is no handrail along the lower stair case and one should be installed as a safety measure.

No handrail.

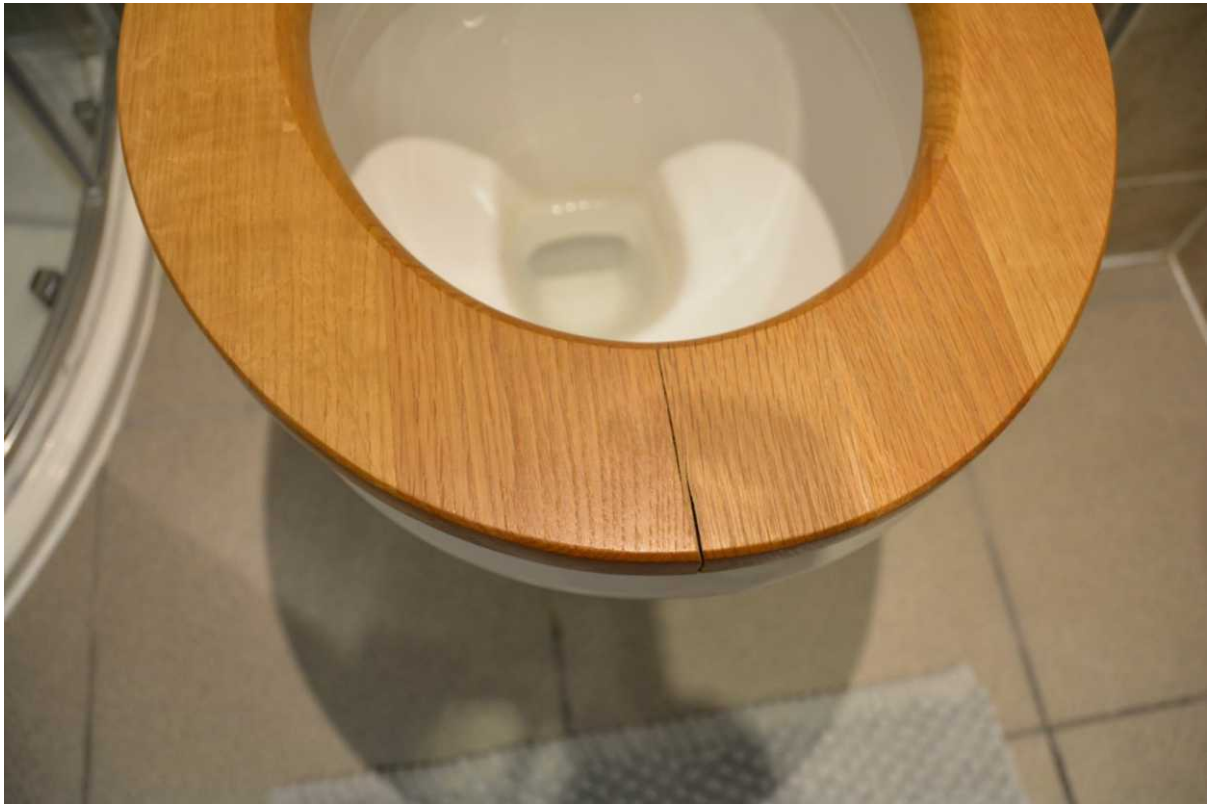
Crack in toilet seat.
