Your survey report

West Mead, Manor Road, Wirral, Merseyside,
United Kingdom, CH63 1JA

Inspection date

01/07/2025

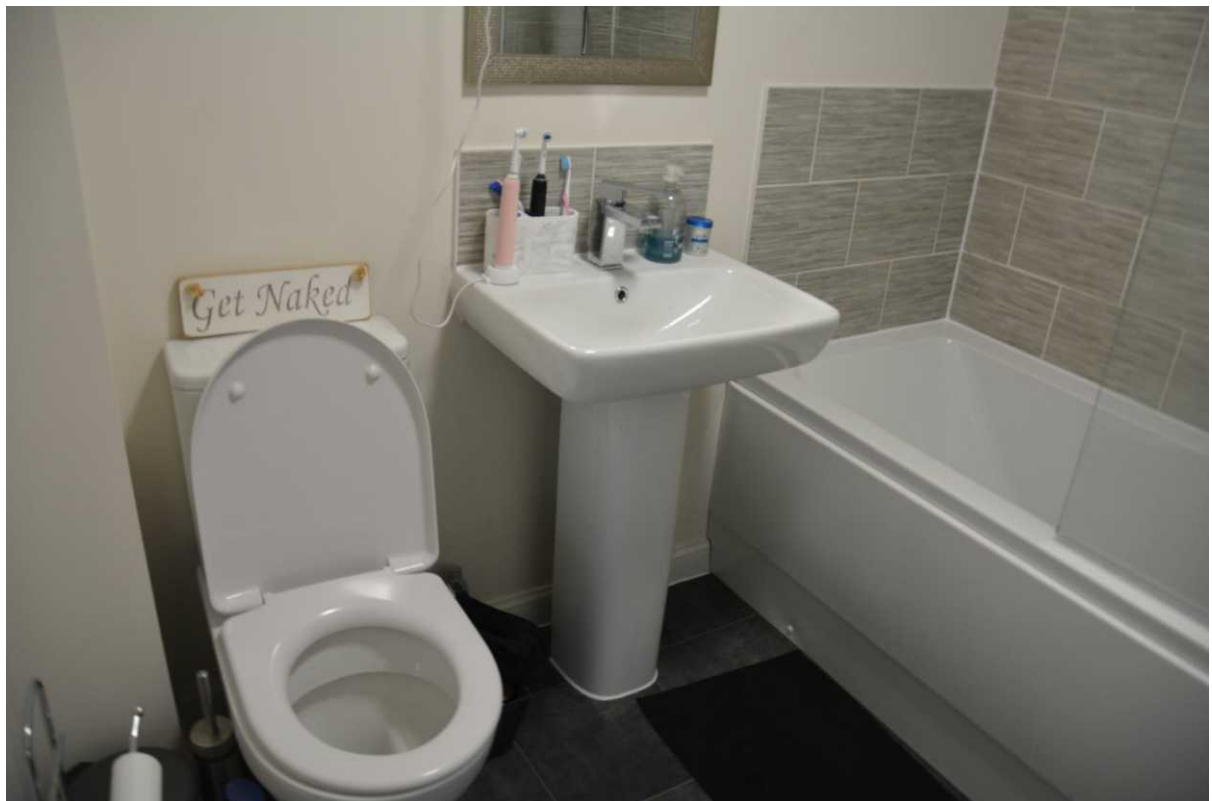
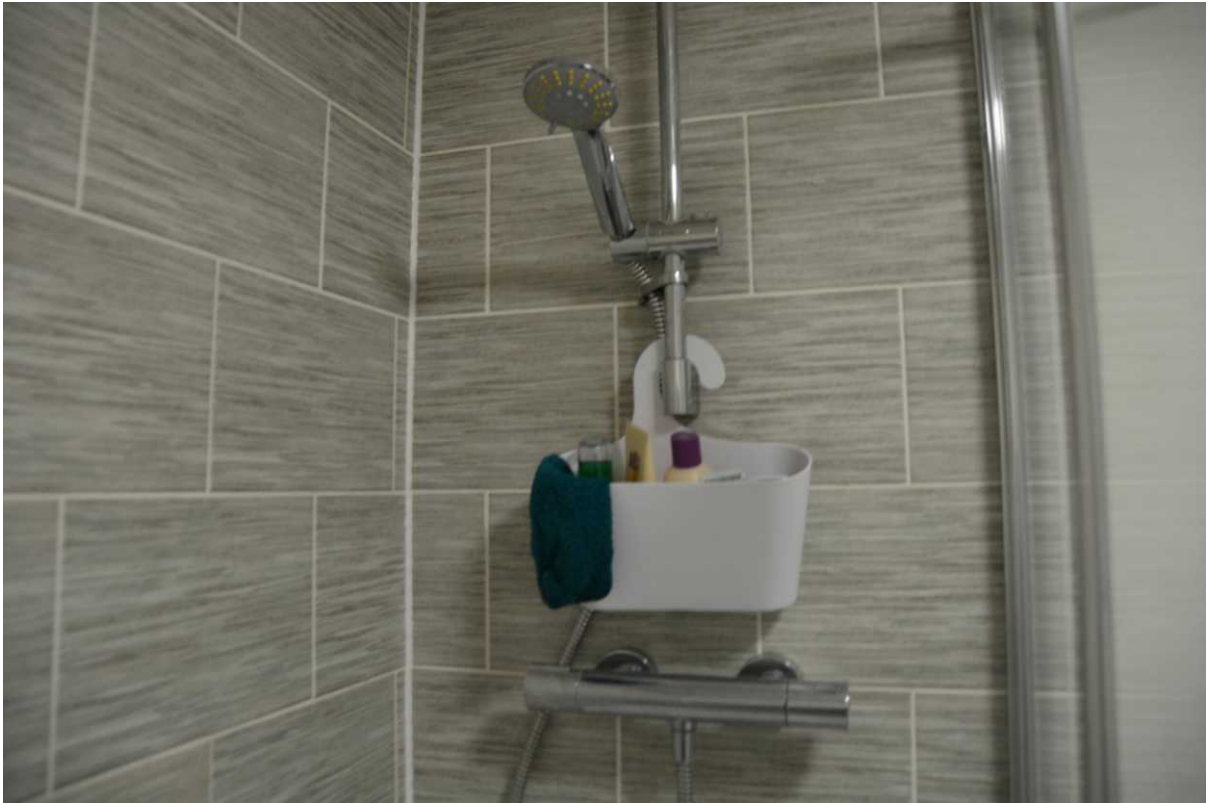
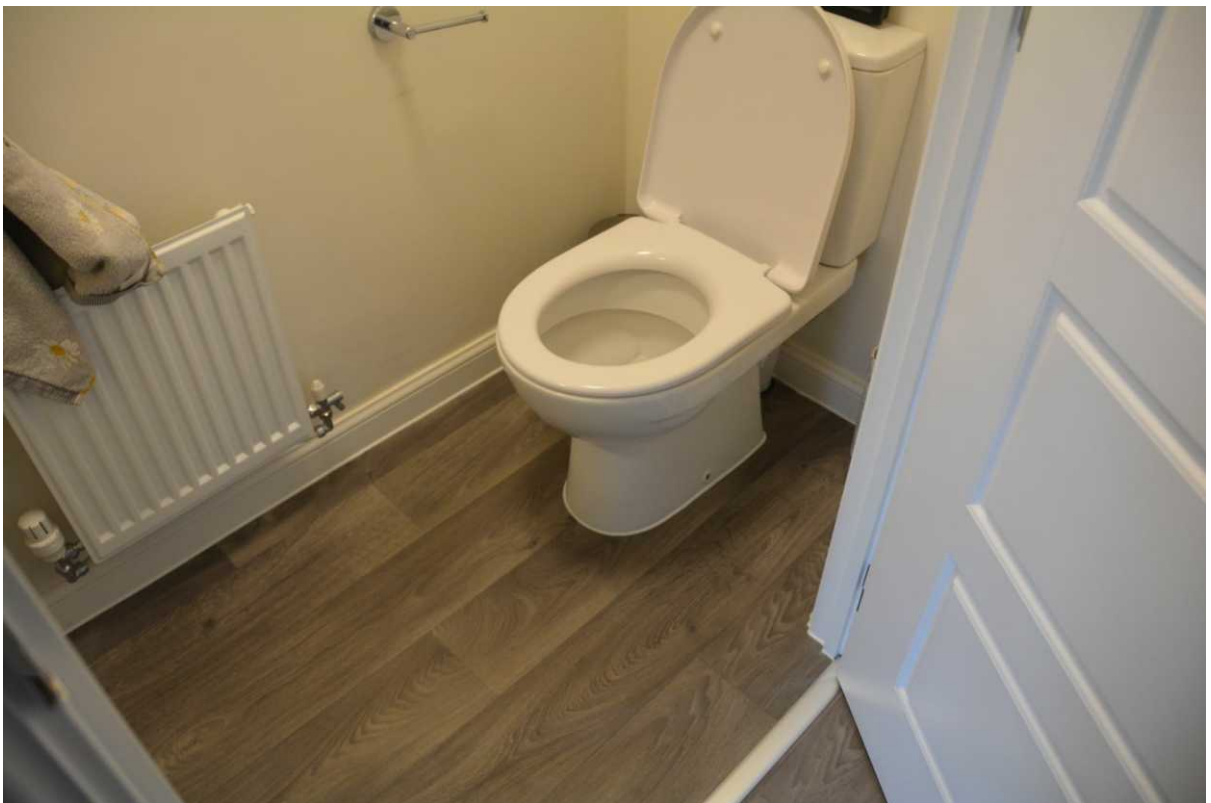
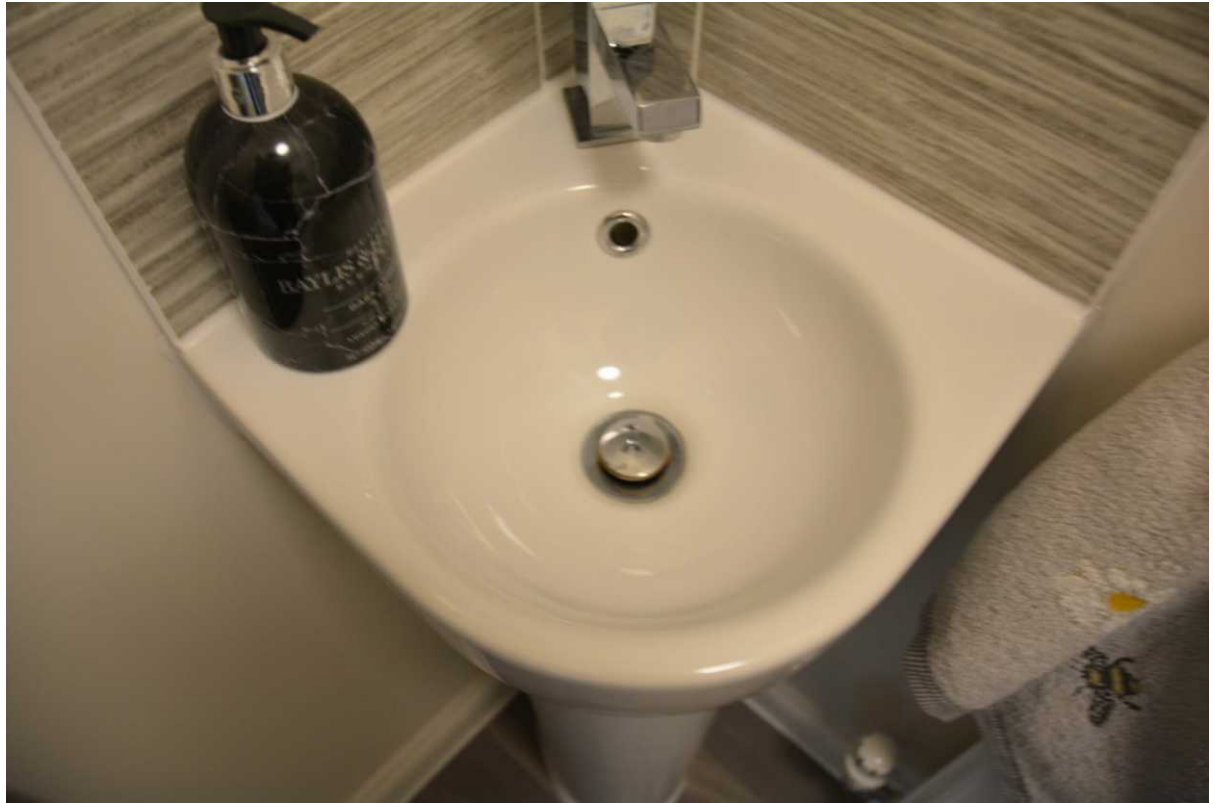
The water pressure was checked to several draw-off points and found to be adequate. Water pressure can vary seasonally and during times of demand, both within the property and in the locality. It is recommended that should you wish to install water pressure sensitive items, such as a power shower, that further enquiries are made initially.

Most of the distribution and waste pipework is concealed beneath or behind sanitary ware items and whilst there were no obvious signs of leaks, the risk of hidden defects exists.

Bathroom fittings.
